**Building Information - Bethel Local SD (48611) - Bethel Elementary**

**Building Construction Information - Bethel Local SD (48611) - Bethel Elementary (2543)**

Building Component Information - Bethel Local SD (48611) - Bethel Elementary (2543)

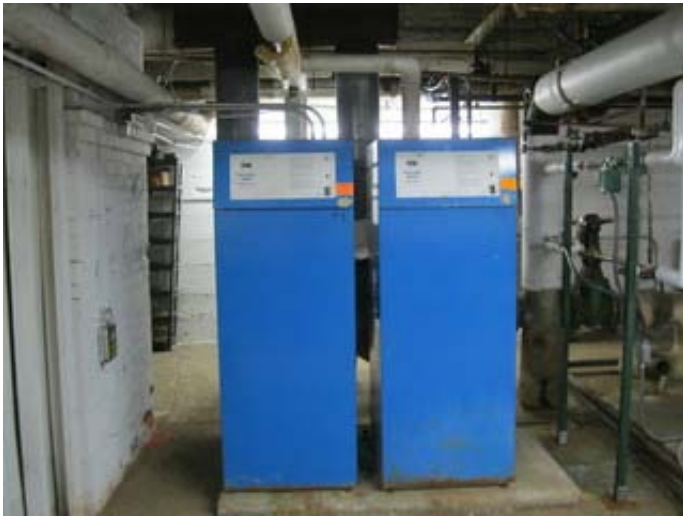
Patterson-Kelley Thermific Natural Gas Fired Heated Water Boilers

Provide new overall heating, ventilating, and air conditioning system to achieve compliance with Ohio Building Code and Ohio School Design Manual standards. Replace the existing ductwork in the 1968 Addition to facilitate efficient exchange of conditioned air with pricing included in conversion to ducted system replacement. Convert the remainder of the overall facility to a ducted system to facilitate efficient exchange of conditioned air. Provide architectural soffits to accommodate the installation of ductwork, with funding provided in conversion to ducted system replacement.

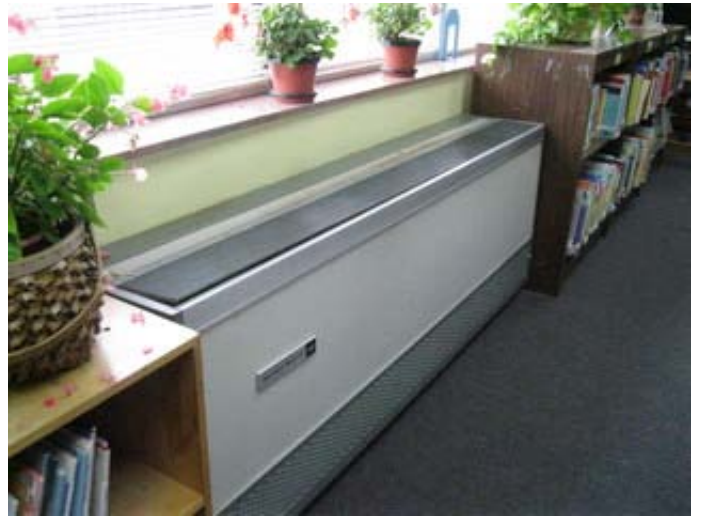
Heating Water Unit Ventilator

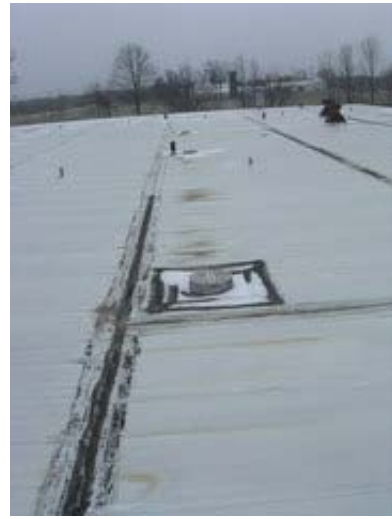
Typical Sheet Steel Roofing

Roof Access, Ladder & Fall Protection Cage:	\$3,850.00	each				1 Required	1 Required			\$7,700.00	(provide when no roof access currently exists)
<b>Other:</b> Repair base flashing and replace receiving metal counterflashing	\$22.00	in.ft.				563 Required			354 Required	\$20,174.00	Replace counterflashing at areas of roof replacement.
<b>Other:</b> Replace Scuppers	\$600.00	each				5 Required				\$3,000.00	Replace scuppers and downspouts at areas of roof replacement.
<b>Other:</b> Roof Ladder Fall Protection Cage	\$60.00	in.ft.				8 Required				\$480.00	Provide fall protection cage at existing roof access ladder.
<b>Sum:</b>			\$387,020.70	\$0.00	\$0.00	\$179,483.20	\$125,017.30	\$21,001.70	\$61,518.50

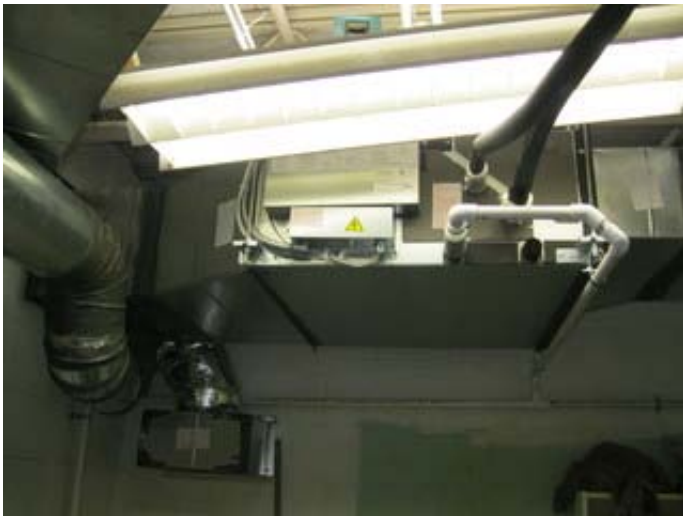
Mitsubishi Ceiling Concealed Indoor Unit/Ducted Fan Coil

**Recommendations:** Provide an air conditioning system to meet with Ohio Building Code and Ohio School Design Manual requirements. Pricing included in Item A. Replace the existing general building exhaust system. Replace the existing Art Program kiln ventilation system due to age and condition.

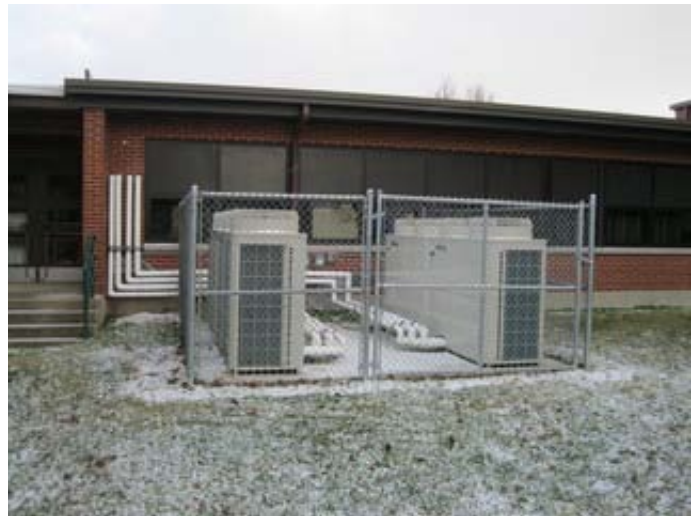
Mitsubishi Electric Fired VRF Heat Pump Condensers

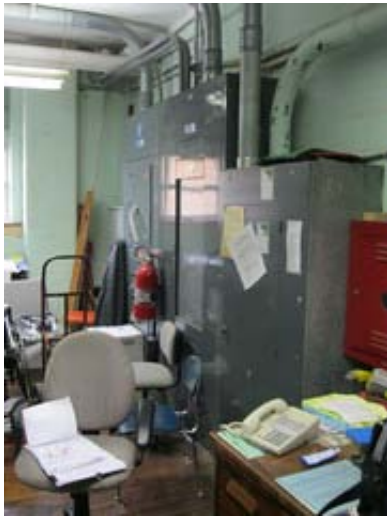
Main Electrical Distribution Panel

**Recommendations:** The entire electrical system for the overall facility requires replacement to meet Ohio School Design Manual guidelines for overall capacity and Classroom capacity due to age, condition, lack of OSDM-required features, and to accommodate the replacement of the air conditioning system. Provide an emergency generator, with funding included in the electrical system replacement. Provide adequate lightning protection safeguards in the overall facility, including associated grounding system, with funding included in the electrical system replacement. Provide control panel, dimmers, and breakers to support the Stage lighting system, with funding included in the electrical system replacement.

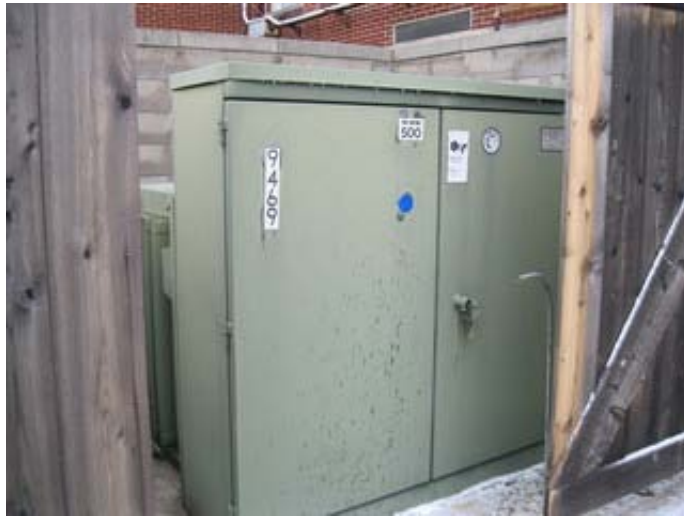
Pad Mounted Transformer

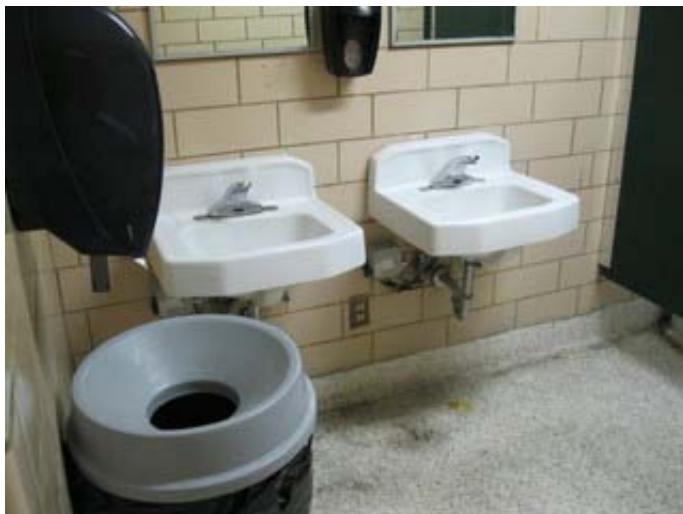
Non-ADA Compliant Wall Hung Lavatories

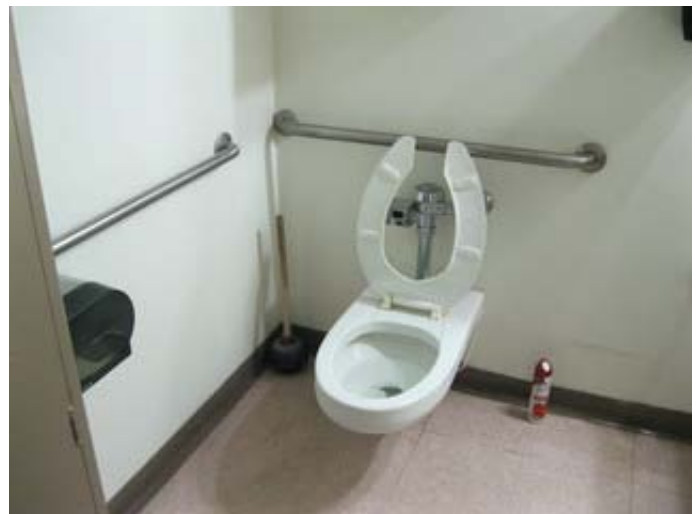
ADA Compliant Wall Hung Flush Valve Toilet

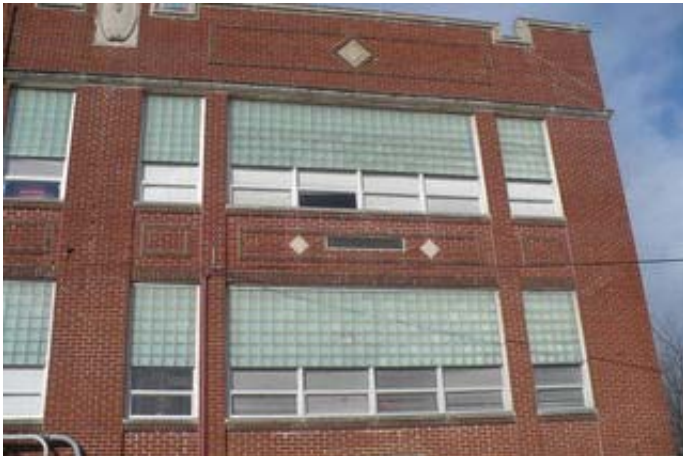
Typical Windows in the 1918 Original Construction

**Recommendations:** Provide a new insulated window system with integral blinds to meet with Ohio School Design Manual requirements throughout the overall facility. Replace interior glass panels with tempered safety glass to comply with the OBC. Exterior door vision panel replacement is addressed in Item S in exterior door replacement scope. Replacement of glass block is included with window replacement.

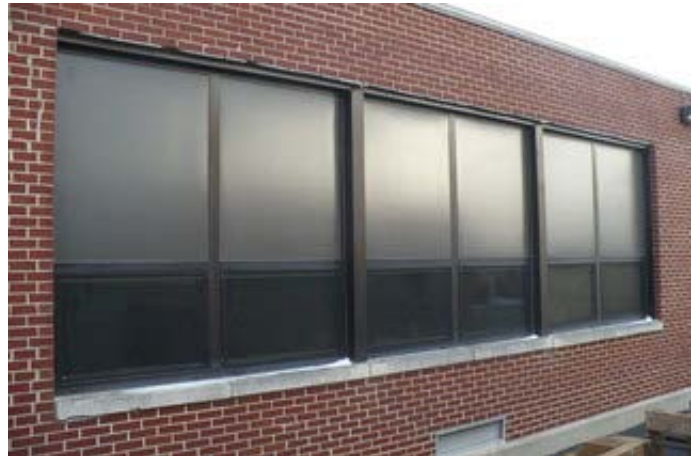
Typical Windows in the 1951 Addition

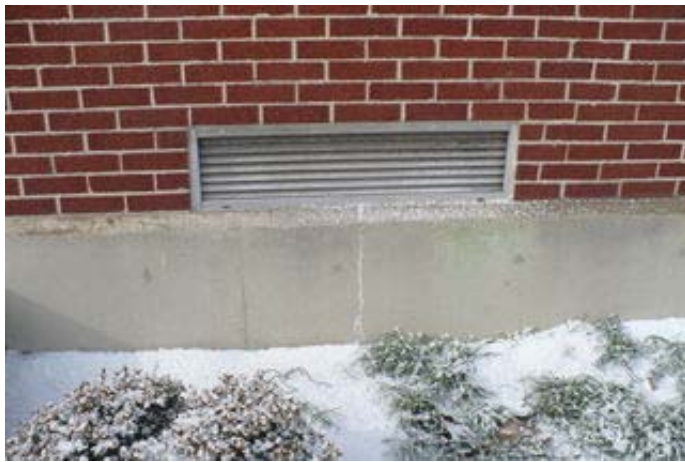
Typical Foundation Crack in the 1951 Addition

**Recommendations:** Repair areas of cracking and spalling through the overall facility.

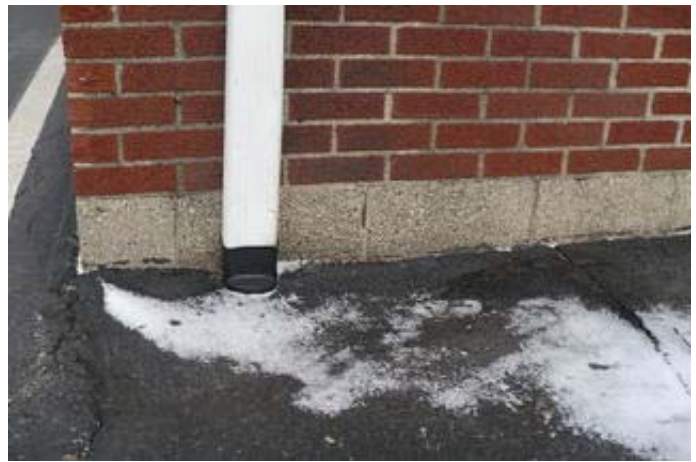
CMU Foundation Wall of the 1956 Music Addition

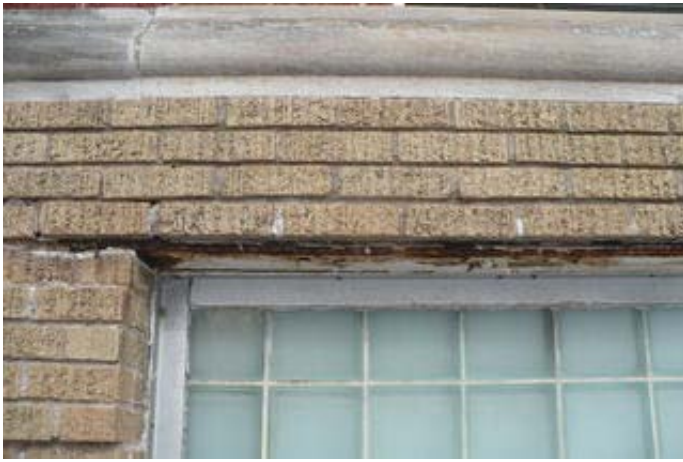
Typical Lintel in 1918 Original Construction

Coping Replacement Stone and Masonry:	\$100.00	n.ft.				550 Required	82 Required			\$63,200.00	(remove and replace)
Install Control Joints	\$60.00	n.ft.				360 Required	48 Required	51 Required		\$27,540.00	
<b>Other:</b> Chimney Repairs	\$12.75	sq.ft. (Qty)				653 Required				\$8,325.75	Repair existing chimneys as required.
<b>Other:</b> Masonry repairs	\$12.75	sq.ft. (Qty)				100 Required	24 Required			\$1,581.00	Repair exterior masonry as required.
<b>Other:</b> New Masonry Infill	\$24.00	sq.ft. (Qty)				64 Required	24 Required	66 Required		\$3,696.00	Provide masonry infill for existing unit ventilator openings in existing walls.
<b>Other:</b> Repair and Paint Exterior Soffits	\$7.50	sq.ft. (Qty)					250 Required			\$1,875.00	Repair and paint exterior soffits as required.
<b>Other:</b> Repoint Stone Trim and Window Sills	\$7.50	sq.ft. (Qty)				600 Required	50 Required	12 Required		\$4,965.00	Repoint stone trim and window sills as required.

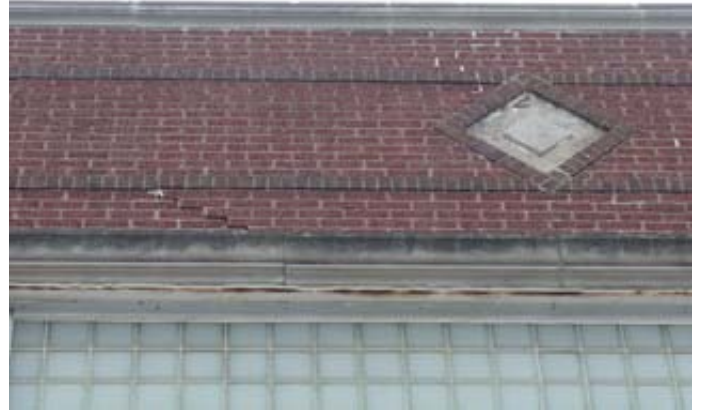
Masonry Repair Needed in 1918 Original Construction

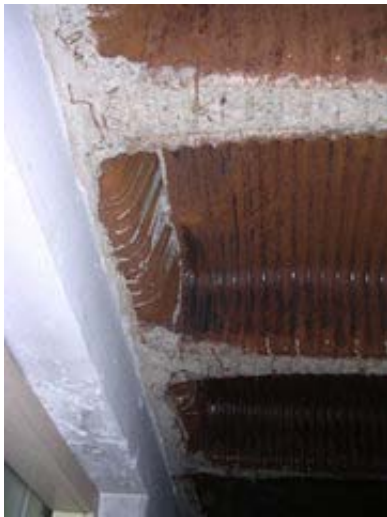
Typical Cast In Place Concrete Floor Structure - 1918 Original Construction

**Recommendations:** Provide fire separation assembly for wood roof structure in the 1918 Original Construction.

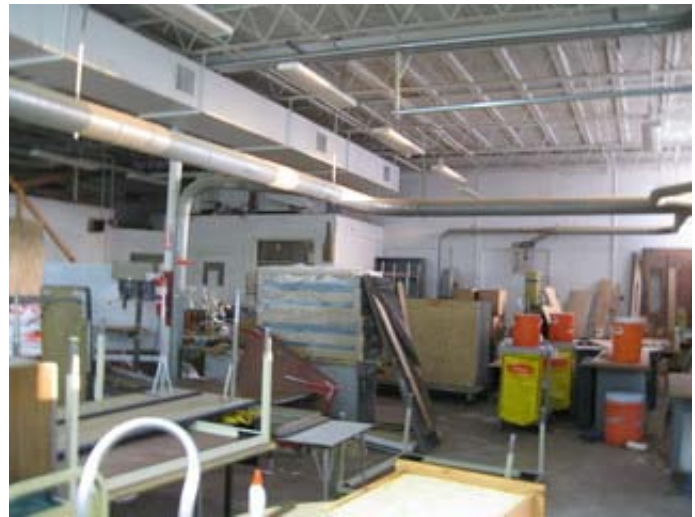
Typical Steel Joist and Tectum Deck Construction - 1968 Addition

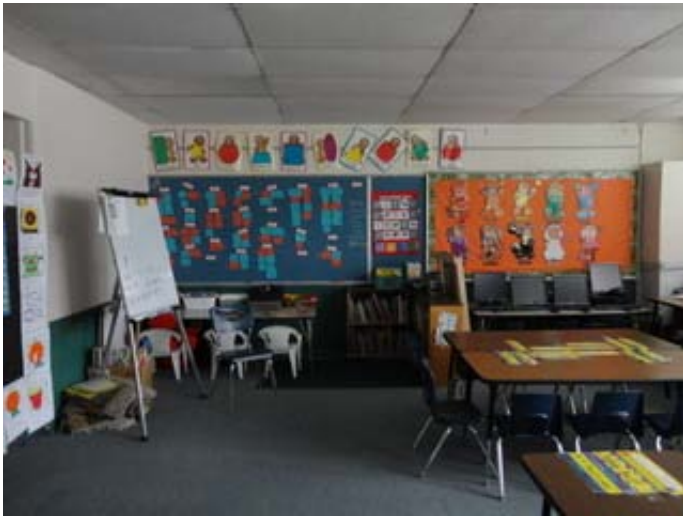
Typical Classroom Finishes in 1918 Original Construction

<b>Other:</b> Plaster Refinishing (Qty)	\$14.00	sq.ft. (Qty)				600 Required				\$8,400.00	Refinish plaster as required.
<b>Other:</b> Provide sound attenuation.	\$3.00	sq.ft. (Qty)				1,955 Required	848 Required	457 Required		\$9,780.00	Provide acoustical surface treatment for the Gymnasium, Student Dining, Media Center, and Music spaces.
<b>Other:</b> Provide Stage equipment.	\$14,000.00	allowance					Required			\$14,000.00	Provide Stage fixed equipment due to condition and being inadequately provided
<b>Other:</b> Repair Terrazzo	\$22.00	sq.ft. (Qty)				300 Required				\$6,600.00	Repair damaged terrazzo flooring as required.
<b>Sum:</b>			\$1,408,274.23	\$2,000.00	\$0.00	\$852,093.92	\$375,363.39	\$27,378.05	\$151,438.87

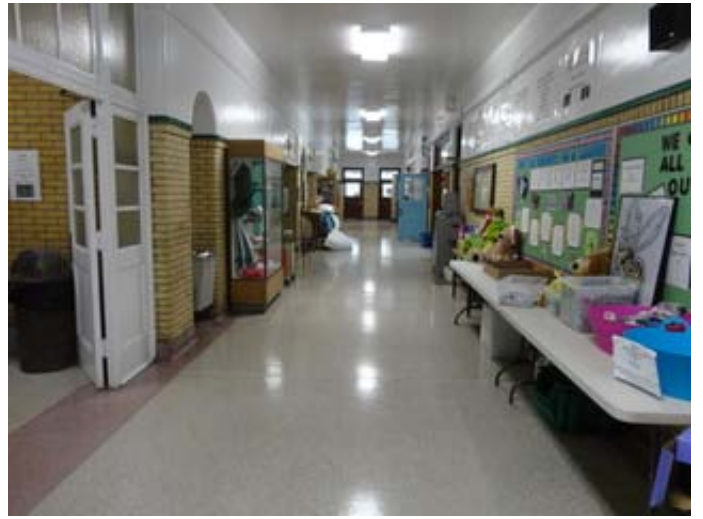
Typical Corridor Finishes in 1918 Original Construction

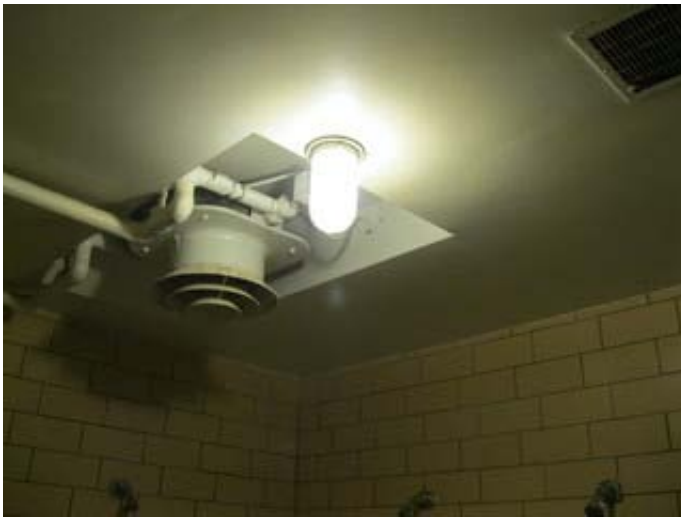
Surface Mount Incandescent Light Fixture

Provide complete replacement of lighting system due to age, condition, inadequate lighting levels, lack of multilevel switching, the utilization of incandescent fixtures, and installation of systems outlined in Items A, C, J, and U.

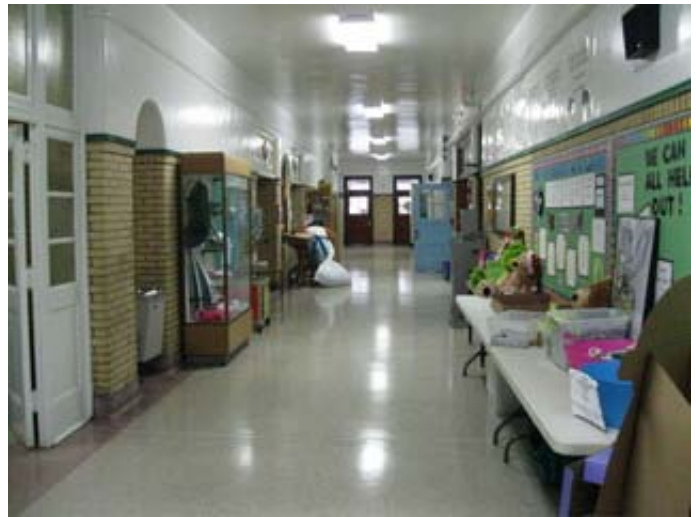
Surface Mount 1x4 Direct Fluorescent Light Fixtures

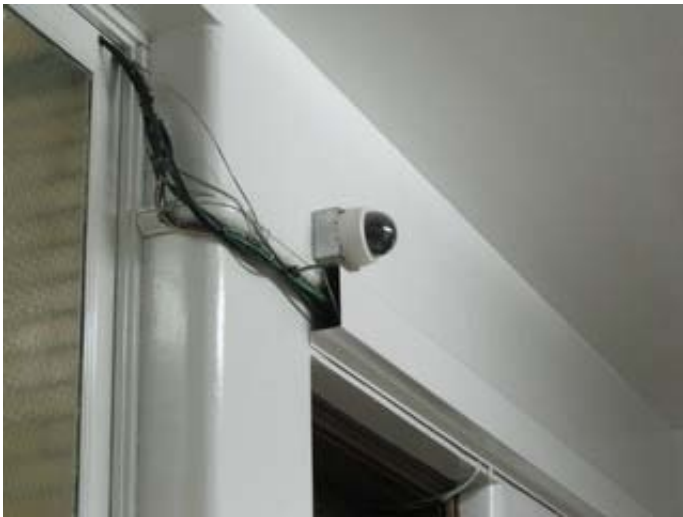
Security System CCTV Camera

**Recommendations:** Provide complete replacement of security system to meet Ohio School Design Manual guidelines. Provide complete replacement of exterior site lighting system to meet Ohio School Design Manual guidelines. Provide for the replacement of playground fencing to meet Ohio School Design Manual guidelines and due to condition, funding included in complete replacement of security system.

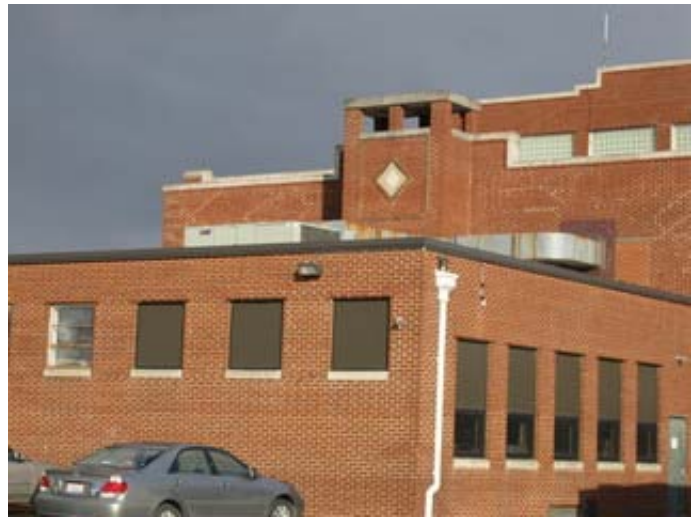
HID High Pressure Sodium Surface Mount Light Fixture

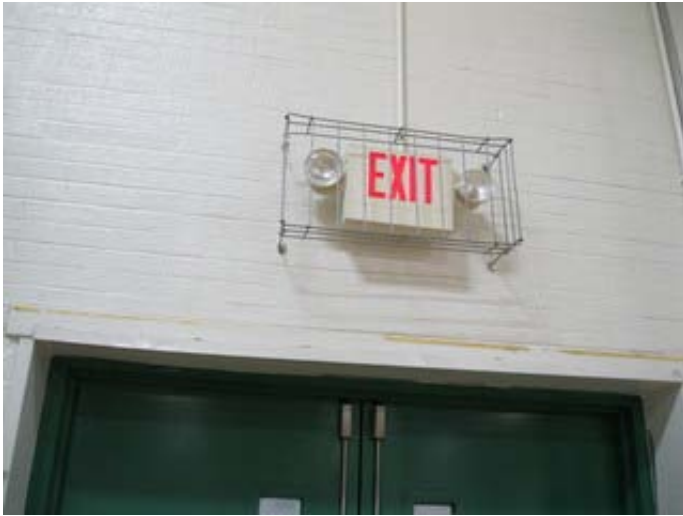
Non-Compliant Exit Sign and Emergency Egress Light Fixture

**Recommendations:** Provide complete replacement of emergency / egress lighting system to meet Ohio School Design Manual guidelines.

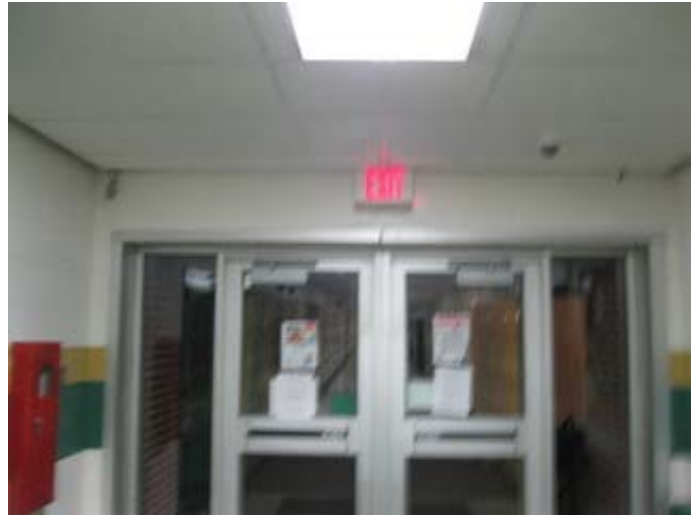
Non-Compliant Exit Sign

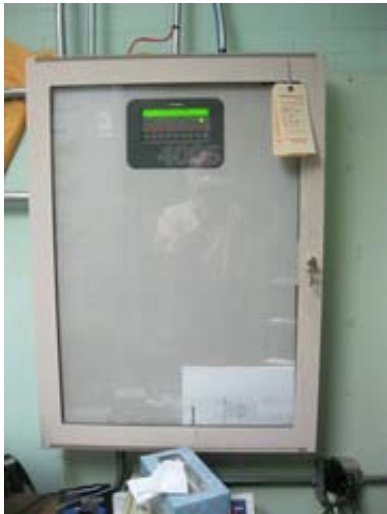
Fire Alarm Control Panel

**Recommendations:** Provide complete replacement of fire alarm system in the overall facility to meet OBC, NFPA, and Ohio School Design Manual guidelines.

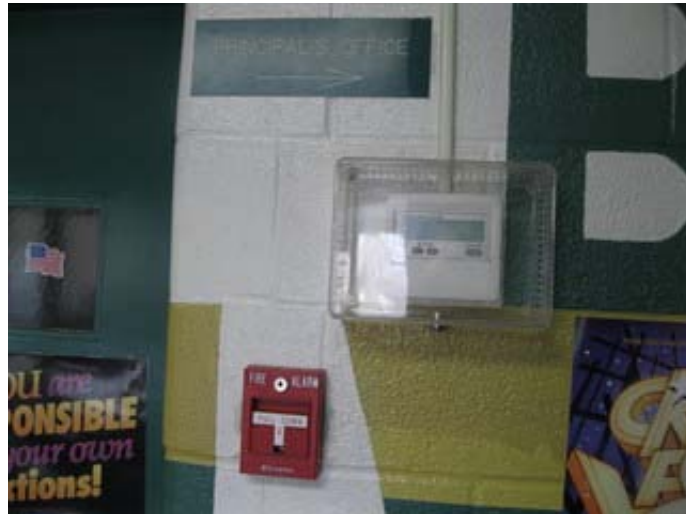
Fire Alarm System Manual Pull Station

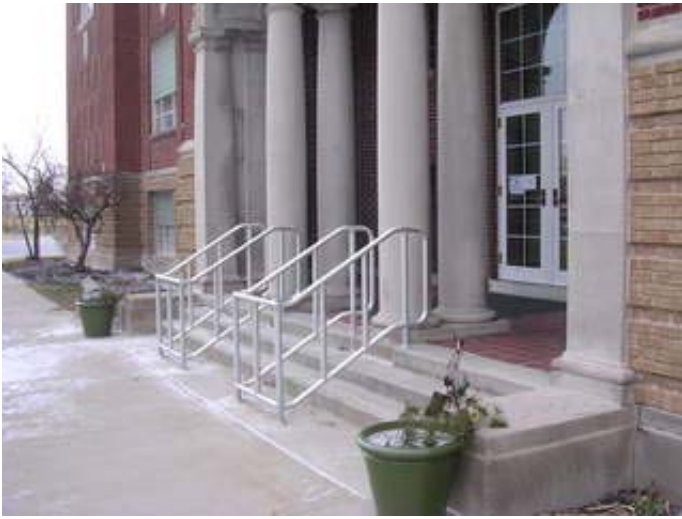
Non-Compliant Main Entry Stairs

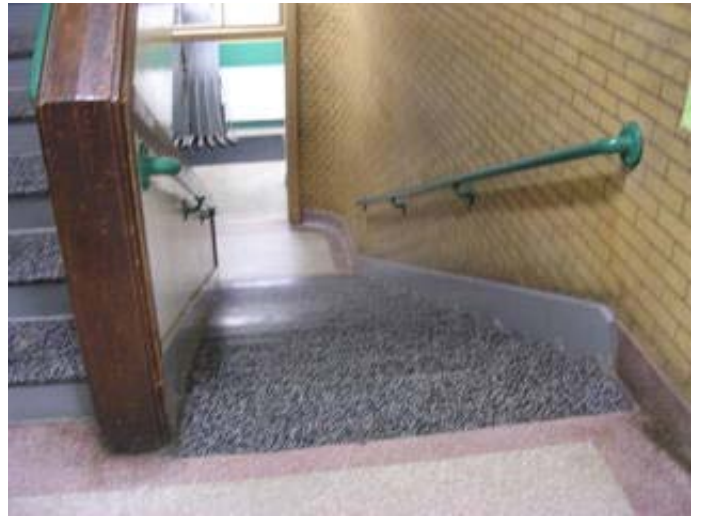
Typical Non-Compliant Stairs/Hand Rails

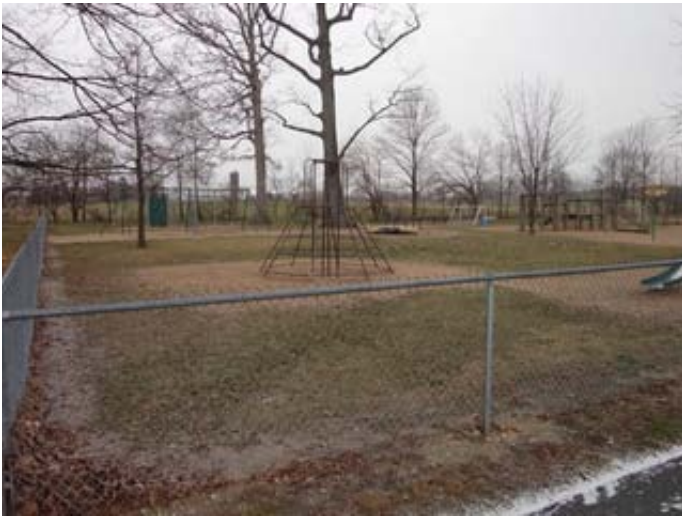
Playground and Fencing

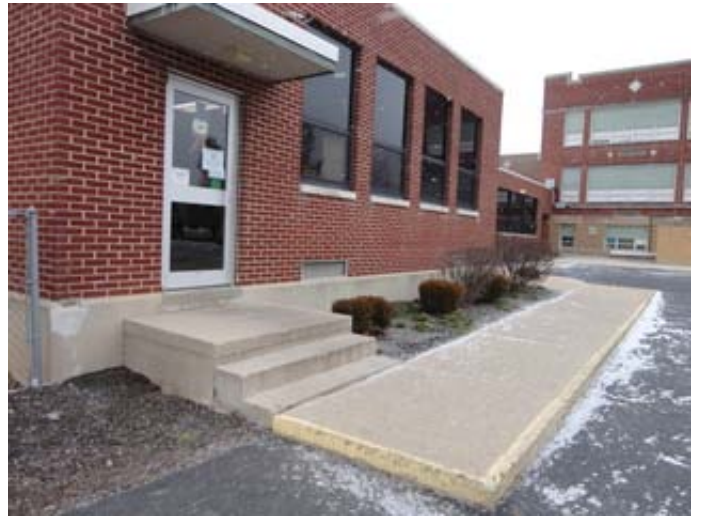
Steps and Sidewalk

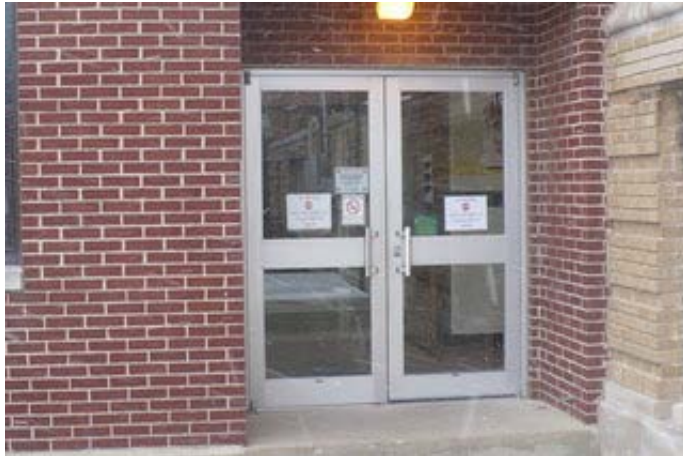
Typical Entrance Doors in 1951 Addition

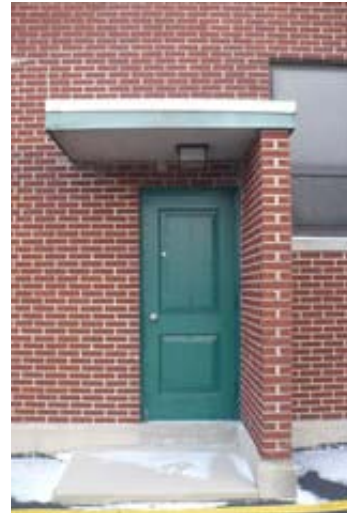
Typical Wood Exterior Door at the 1951 Addition

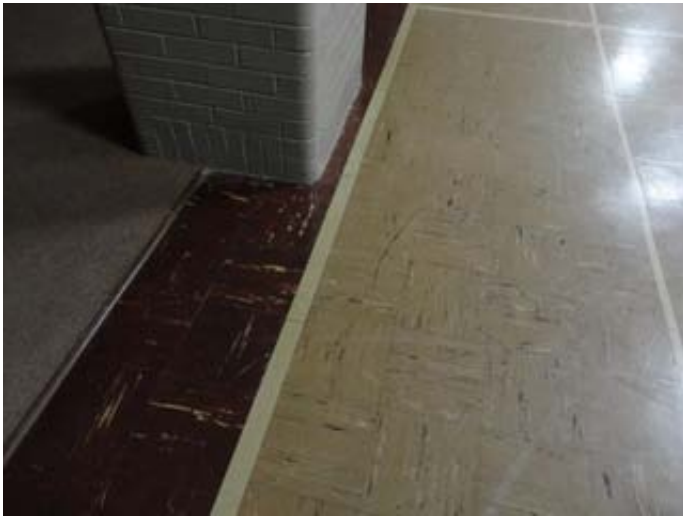
VAT in Gymnasium

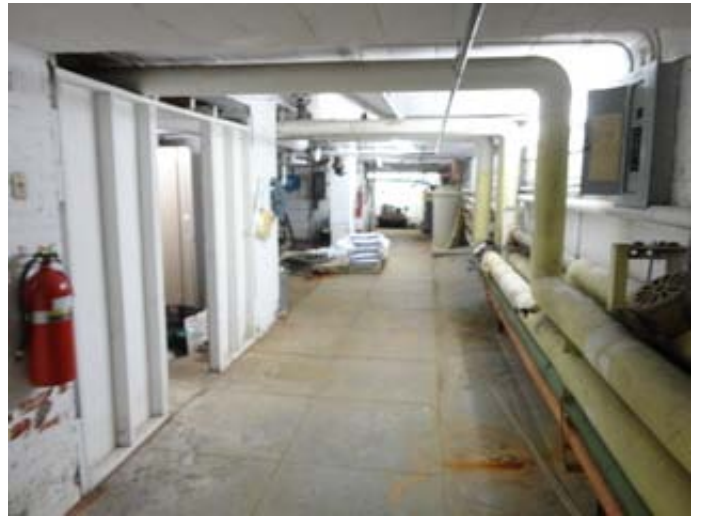
Asbestos Pipe Insulation
