Building Information - Bethel Local SD (48611) - Bethel High

Program Type	Classroom Facilities Assistance Program (CFAP) - Regular
Setting	Rural
Assessment Name	Bethel High (2576) FINAL - TPA Assessment with 2014 Costs
Assessment Date	2013-01-18
Cost Set:	2014
Building Name	Bethel High
Building IRN	2576
Building Address	7490 S St Rt 201
Building City	Tipp City
Building Zipcode	45371
Building Phone	937.845.9487
Acreage	152.30
Current Grades:	9-12
Teaching Stations	25
Number of Floors	1
Student Capacity	154
Current Enrollment	271
Enrollment Date	2014-05-02

GENERAL DESCRIPTION

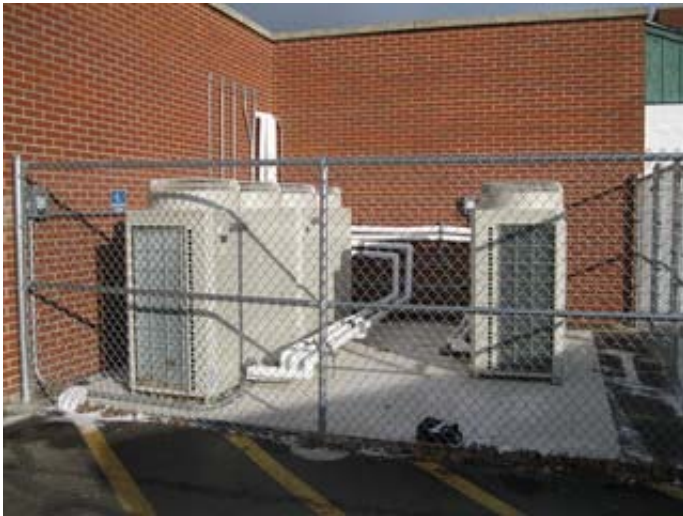
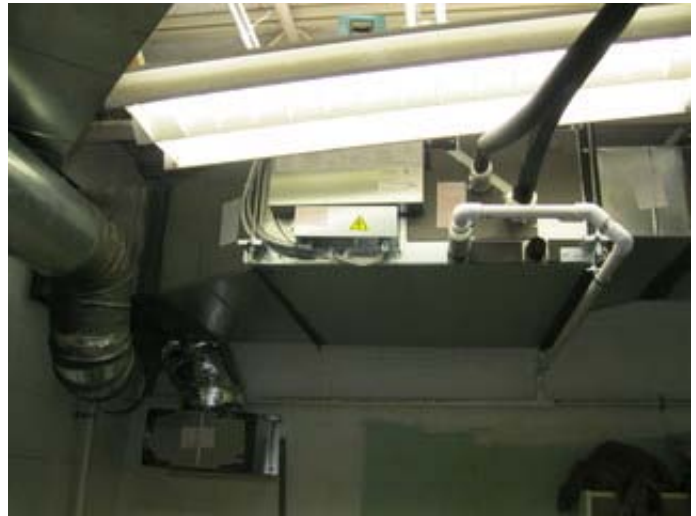
Description: The existing system for the overall facility is an electric fired ducted VRF heat pump type system, installed in 2004, and is in good to fair condition. The heating system is an electric fired ducted VFR heat pump type system, with DX cooling. This system is not 2 or 4-pipe system with a capacity for simultaneous heating and cooling operation, which is not compliant with the OSDM requirements for basic system type. These areas are not equipped with a central air conditioning system. The VRF heat pumps, manufactured by Mitsubishi, were installed in 2004 and are in good to fair condition. Heating forced air is distributed to terminal units consisting of Mitsubishi ceiling concealed indoor units/ducted fan coils. The terminal equipment was installed in 2004 and is in good to fair condition. The system does not appear to comply with the 15 CFM per person fresh air requirements of the Ohio Building Code mechanical code and Ohio School Design Manual. The pneumatic and electric type system temperature controls are original to each addition, with incremental upgrades, and are in fair to poor condition. The system does not feature individual temperature controls in all spaces required by the OSDM. The overall system does not feature any central energy recovery systems. The overall facility is equipped with louvered interior doors to facilitate Corridor utilization as return air plenums. See Item J for replacement of doors. The existing system is ducted, but the ductwork cannot be integrated into a possible future system due to arrangement, air volume, and routing of existing ductwork. The existing system ductwork in the 1964 Addition is run on the exterior and roof of the addition as existing floor to structural deck heights will not accommodate the installation of properly sized ductwork for a future Ohio School Design Manual approved system. The overall heating system is evaluated as not being in safe and efficient working order, and long term life expectancy of the existing system is not anticipated. The structure is not equipped with a central air conditioning system. The site does not contain any underground fuel tanks.

Rating: 3 Needs Replacement

Mitsubishi Heat Pump Condensing Units

Mitsubishi Concealed Ceiling Unit

Recommendations: Provide new overall heating, ventilating, and air conditioning system to achieve compliance with Ohio Building Code and Ohio School Design Manual standards. Replace the existing ductwork to facilitate efficient exchange of conditioned air with pricing included in conversion to ducted system replacement. Provide conversion of the 1964 Addition exterior and roof mounted ductwork type system to an interior ducted type system to facilitate efficient exchange of conditioned air. Provide architectural soffits in the 1964 Addition to accommodate the installation of ductwork, with funding provided in conversion to ducted system replacement.

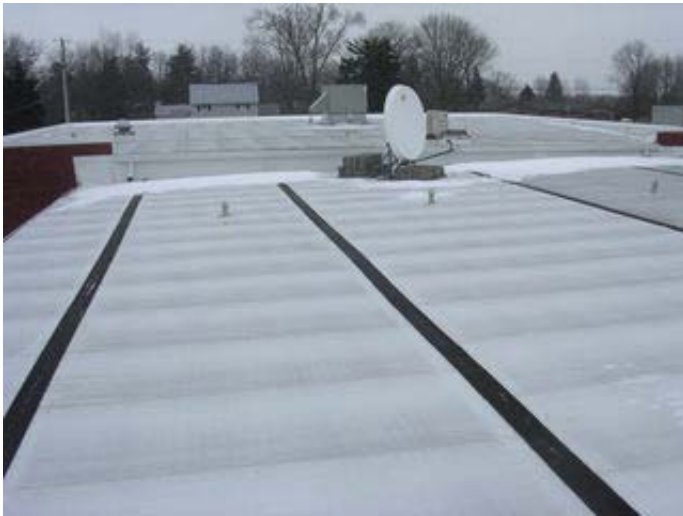
Description: The roof over the 1959 Original Construction is a galvanized standing seam metal roof system that was installed in 1999, that is in fair condition. The roof over the 1964 Addition is a coated sheet steel system that was installed in 1999, and is in poor condition. The roof over the 1999 Addition is a standing seam metal roof system that was installed in 1999, and is in good condition. There are no District reports of current leaking. Minor signs of past leaking were observed during the physical assessment. Access to the roof was gained by a portable ladder. Provide roof access hatches / ladders as appropriate to facilitate access to all levels of low slope roof surfaces. Fall safety protection cages are not required. There were no observations of standing water on the roof. Metal cap flashings and copings are in fair condition. Roof storm drainage is addressed through a system of gutters and downspouts, which are properly located, and in fair condition. The roof is not equipped with overflow roof drains though they are not required on this building. No problems requiring attention were encountered with any roof penetrations. There are covered walkways attached to this structure that connect to modular Classrooms. The steel frame and standing seam metal roof structure is in fair condition but is not addressed within the scope of this assessment.

Rating: 3 Needs Replacement

Typical Steel Panel Roofing

Recommendations: The roof over the 1964 Addition requires replacement to meet Ohio School Design Manual guidelines due to condition. The 1959 Original Construction and 1999 Addition require no renovation or replacement at the present time. The flashing and coping on the 1964 Addition require replacement with the roof replacement. Due to the scope of the roof replacement, gutters and downspouts require replacement. Overflow roof drains are not required for the overall facility. Provide roof access hatches / ladders as appropriate to facilitate access to all levels of low slope roof surfaces.

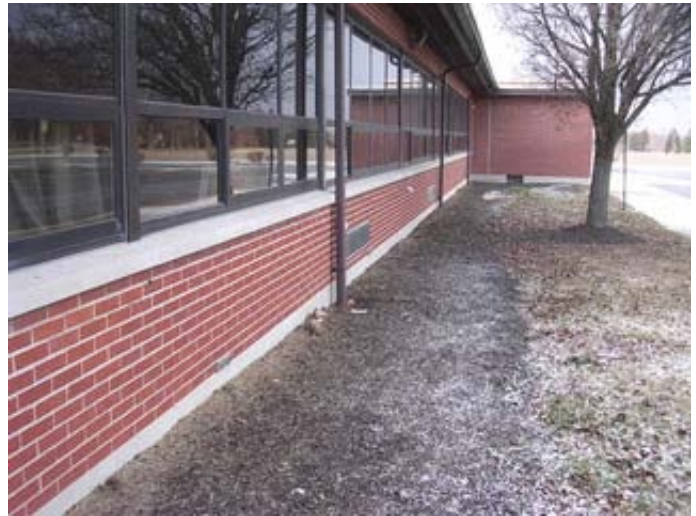
Typical Gutter and Down Pipe Condition

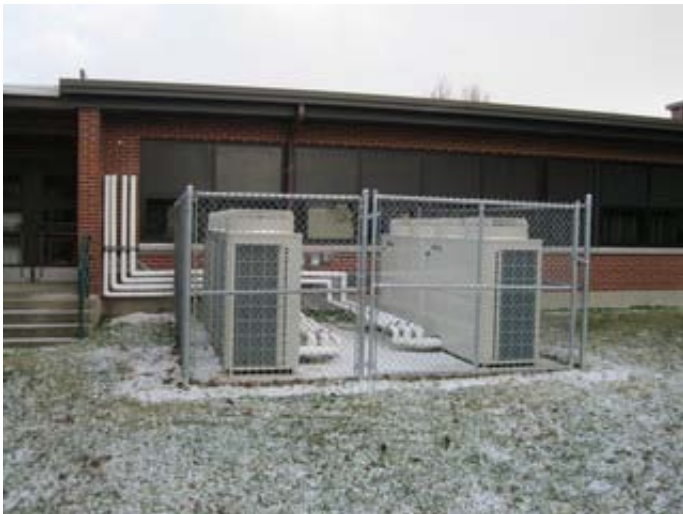
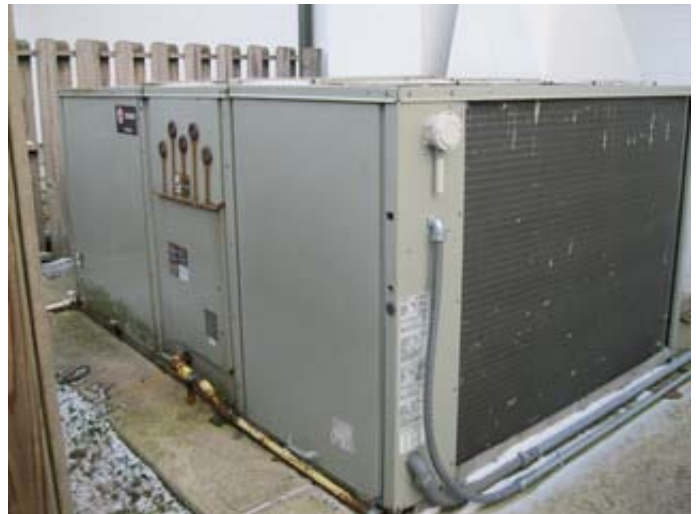
Description: The overall facility is not equipped with a central air conditioning system. Isolated room systems consisting of electric fired ducted VRF heat pump type systems, installed in 2004, and in good to fair condition, are provided throughout the 1959 and 1964 Additions. The ventilation system in the overall facility consists of unit ventilators, air handling units, and Mitsubishi concealed ceiling units/ducted fan coils, original to each addition, with incremental upgrades, and in fair to poor condition, providing fresh air to Classrooms, and other miscellaneous spaces such as the Gymnasium and Media Center. Relief air venting is provided by louvered interior doors, unit ventilators, air handling units, concealed ceiling units/ducted fan coils, and central relief fans. The ventilation system does not appear to meet the Ohio Building Code 15 CFM per occupant fresh air requirement. The overall system is not compliant with Ohio Building Code and Ohio School Design Manual requirements. Dust collection systems are not required in this facility. Exhaust systems for Restrooms, Storage Rooms, Custodial Closets, Maintenance Workrooms, P.E. Workroom & Storage, Art Material Storage, and Art Rooms are inadequately placed, and in fair to poor condition. The Art Program is equipped with one (1) kiln, and the existing kiln ventilation system is inadequate.

Rating: 2 Needs Repair

Mitsubishi Heat Pump Condensing Units

Trane HVAC Unit

Recommendations: Provide an air conditioning system to meet with Ohio Building Code and Ohio School Design Manual requirements. Pricing included in Item A. Replace the existing general building exhaust system. Replace the existing Art Program kiln ventilation system due to age and condition.

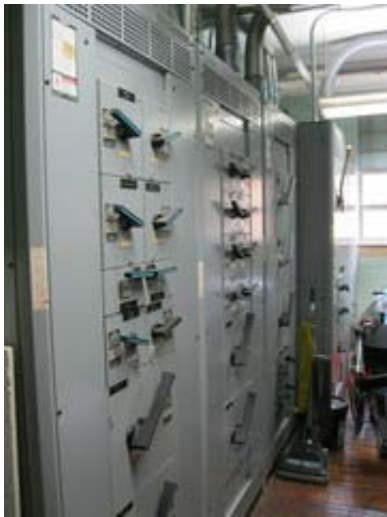
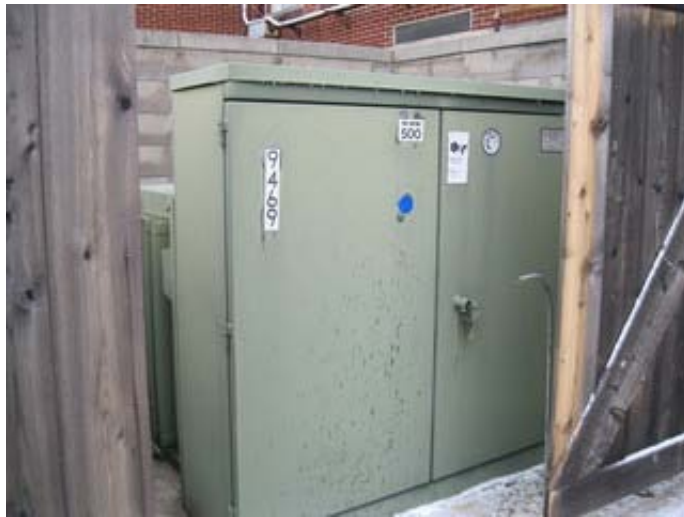
Description: The electrical system provided to the overall facility is an extension of the 208Y/120vac volts, 2,000 amp, 3 phase and 4 wire system provided in the 1918 Original Construction of the Elementary School. The system was installed in 1968, with upgrades in 1993, and is in fair to poor condition. Power is provided to the school by a single utility-owned, pad-mounted transformer located outside the Mechanical Room of the 1918 Original Construction of the Elementary School in a wood and masonry enclosure, and is fair condition. The panel system installed in 1968, with upgrades in 1993, is in fair to poor condition, and cannot be expanded to add additional capacity. The Classrooms are not equipped with adequate electrical outlets. The typical Classroom contains four (4) general purpose outlets, zero (0) dedicated outlets for a group of three (3) Classroom computers, and zero (0) dedicated outlets for each Classroom television. Some Classrooms are equipped with as many as five (5) general purpose outlets, while others are equipped with as few as two (2) general purpose outlets. There are not any spaces that have no electrical outlets. The Corridors in the overall facility are equipped with adequate electrical outlets for servicing. Adequate GFI protected exterior outlets are not provided around the perimeter of the building. The facility is not equipped with an emergency generator. Adequate lightning protection safeguards are not provided. The Stage is located in the 1918 Auditorium Fixed Seating Addition of the Elementary School. The electrical systems in the overall facility, do not meet Ohio School Design Manual requirements in supporting the current needs of the school, and will be inadequate to meet the facility's future needs.

Rating: 3 Needs Replacement

Main Electrical Distribution Panel

Pad Mounted Transformer

Recommendations: The entire electrical system for the overall facility requires replacement to meet Ohio School Design Manual guidelines for overall capacity and Classroom capacity due to age, condition, lack of OSDM-required features, and to accommodate the replacement of the air conditioning system. Provide an emergency generator, with funding included in the electrical system replacement. Provide adequate lightning protection safeguards in the overall facility, including associated grounding system, with funding included in the electrical system replacement.

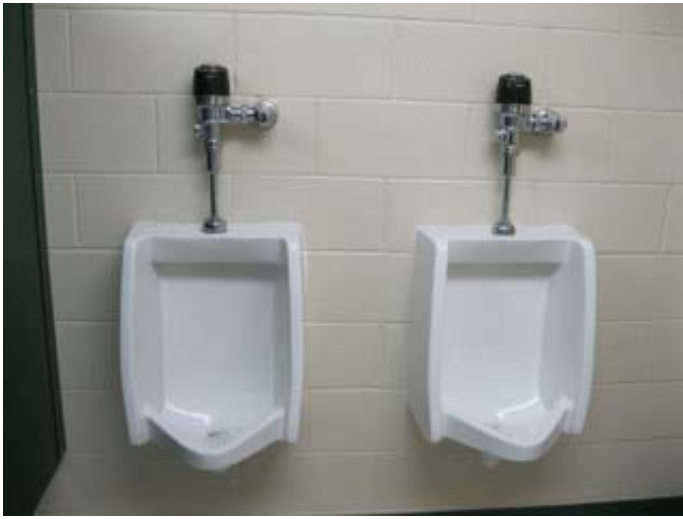
Description: The service entrance, located in the 1918 Original Construction of the Elementary School, is equipped with 2 reduced pressure backflow preventers in good condition. The facility is equipped with a water treatment system located in the 1918 Original Construction of the Elementary School, and the system is in fair condition. The domestic water supply piping in the overall facility is galvanized and copper, is original to each addition, and is in fair to poor condition. The waste piping in the overall facility is cast iron and galvanized with some PVC, is original to each addition, and is in fair to poor condition. The water heater and storage tank is located in the 1918 Original Construction of the Elementary School and is a 100 gallon AO Smith LP gas water heater, installed in 2011, in good condition, with a separate 350 gallon storage tank in poor condition. The overall facility is also equipped with roof top solar panels and a storage tank providing supplemental domestic heated water. The equipment was installed recently and is in good condition. The overall facility contains 1 Large Group Restroom for boys, 1 Large Group Restroom for girls, 0 Locker Room Restrooms for boys, 0 Locker Room Restrooms for girls, 0 Locker Room Restrooms for staff, 0 Kitchen Restrooms, 0 Health Clinic Restrooms, 0 Restrooms associated with Special Education Classrooms, and 0 Restrooms for staff. Boys' Large Group Restrooms contain 2 non-ADA floor mounted infra-red toilets, 2 ADA and 4 non-ADA floor mounted infra-red urinals, as well as 3 non-ADA wall mounted lavatories. Girls' Large Group Restrooms contain 4 non-ADA floor mounted infra-red toilets, as well as 3 non-ADA wall mounted lavatories. There are no Staff Restrooms. Condition of fixtures is fair to poor. The facility is equipped with 3 non-ADA electric water coolers, in fair condition. Due to existing grade configuration, no Elementary Classrooms are present. The Special Education Classroom is not equipped with the required Restroom. The Kitchen is located in the 1918 Original Construction of the Elementary School. The Health Clinic is located in the 1959 Original Construction of the Middle School. Due to existing grade configuration, there are no Kindergarten / Pre-K Classrooms. The Kitchen is located in the 1918 Original Construction of the Elementary School. The school does meet the OBC requirements for fixtures and drinking fountains / electric water coolers. Per OBC and OSDM requirements this facility should be equipped with 6 toilets, 4 urinals, 6 lavatories, and 3 electric water coolers, and at present it is equipped with 10 toilets, 5 urinals, 10 lavatories, and 3 electric water coolers. ADA requirements are not met for fixtures and drinking fountains (see Item O). Custodial Closets are properly located and are adequately provided with required service sinks or floor drain sinks, which are in fair condition. Science Classrooms / Labs are equipped with the required utility sinks, gas connections, and safety shower / eyewash stations, but the equipment is inadequate due to age and condition. Science Classrooms / Labs are not equipped with the required compressed air connections. Biology or Chemistry Classrooms are equipped with the required acid waste systems, which are inadequate due to age and condition. Adequate exterior wall hydrants are not provided.

Rating: 3 Needs Replacement

Non-ADA Compliant Wall Hung Infra-red Urinals

Recommendations: Replace water supply piping in the overall facility with copper piping due to age and condition. Replace sanitary waste piping in the overall facility due to age and condition. To facilitate the school's compliance with OBC and OSFC requirements, provide 2 lavatories, 4 toilets, and 1 urinal. Due to age, condition, and OSFC standards, replace 6 lavatories, 6 toilets, 4 urinals, and 3 electric water coolers. See Item O for replacement of fixtures related to ADA requirements. Provide two (2) additional exterior wall hydrants. Replace the Science Classroom / Lab utility sinks due to age and condition. Replace Science Classroom / Lab gas connections due to age and condition. Provide Science Classroom / Lab with the required compressed air connections. Replace Science Classroom / Lab safety / eyewash stations due to age and condition. Replace Biology / Chemistry Classroom acid waste systems due to age and condition.

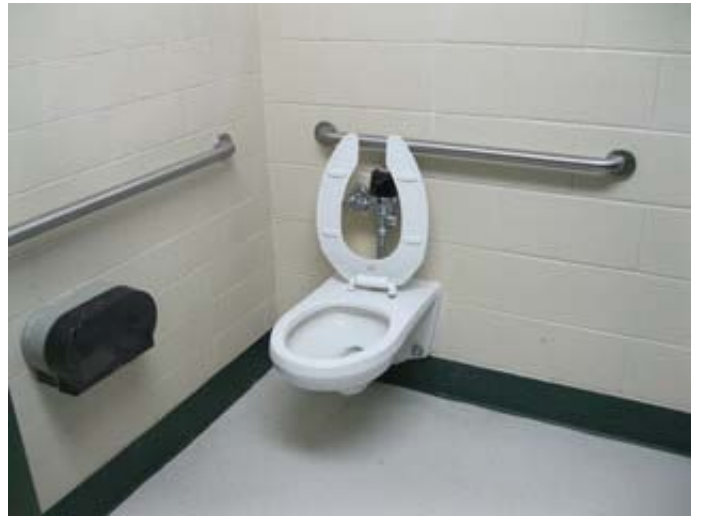
ADA Compliant Wall Hung Toilet

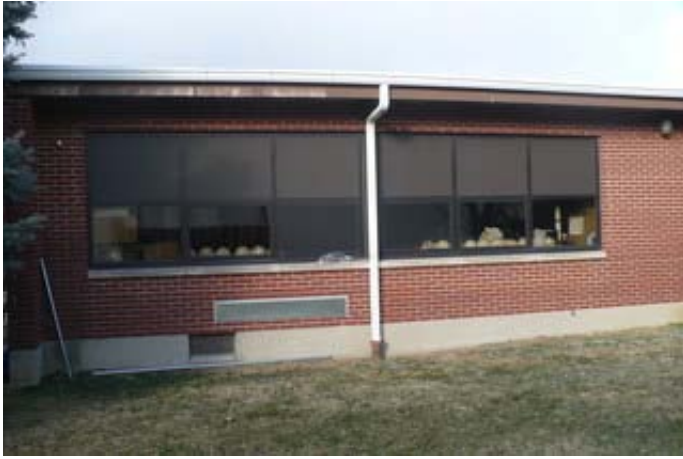
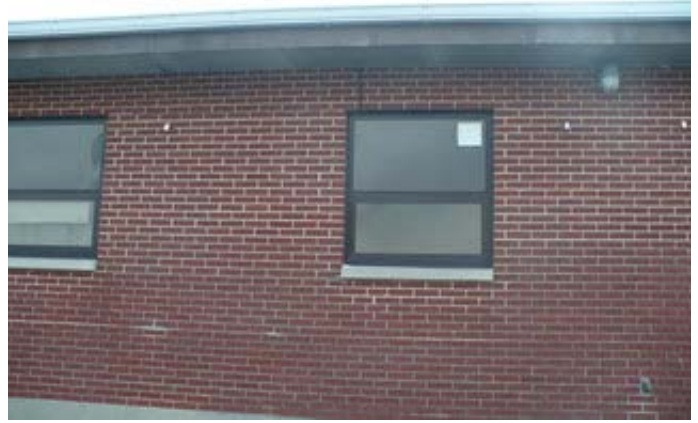
Description: The 1964 Addition is equipped with thermally broken aluminum frame windows with insulated glazing type window system, which was installed in 1987, and is in fair condition. The window system features both operable and inoperable windows throughout the building, and operable windows are not equipped with opening limiters, or insect screens. Window system seals are in fair to poor condition, with moderate air, but minimal water infiltration being experienced. Window system hardware is in fair condition. The window system features no blinds. This facility is not equipped with any curtain wall systems. This facility does not feature any glass block windows. The 1999 Addition is not equipped with any windows. The 1959 Original Construction is addressed in the Junior High Assessment. The exterior doors in the 1964 Addition are equipped with thermally broken aluminum frame sidelights single pane glazing, in fair to poor condition. Exterior door vision panels are single pane glazing. The school does not contain any skylights. The school does not contain any clerestories. Interior glass is OSDM-compliant. Window security grilles are not provided for ground floor windows. There is not a Greenhouse associated with this school.

Rating: 3 Needs Replacement

Typical Classroom Window of 1964 Addition

Typical Prep Room Window of 1964 Addition

Recommendations: Provide a new insulated window system with integral blinds to meet with Ohio School Design Manual requirements, and due to condition. Exterior door vision panel replacement is addressed in Item S in exterior door replacement scope. Window replacement for the 1959 Original Construction is included in the Junior High Assessment.

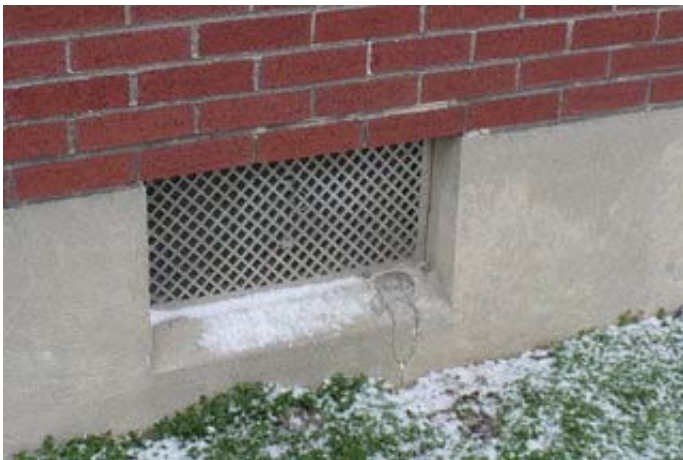
Description: The 1959 Original Construction and 1964 Addition are equipped with concrete foundation walls on concrete footings, which displayed no locations of significant differential settlement, minimal cracking, no leaking, and is in good to fair condition. The 1959 Original Construction and 1964 Addition are on a crawl space, which are in good to fair condition. The 1999 Addition is equipped with concrete foundation walls on concrete footings, which displayed no locations of significant differential settlement, minimal cracking, no leaking, and is in good to fair condition, and is slab on grade. Areas of minor cracking were observed through the overall facility. The District reports that there has been no past leaking. No grading or site drainage deficiencies were noted around the perimeter of the structure that are contributing or could contribute to foundation / wall structural deterioration.

Rating: 2 Needs Repair

Cracks in the Concrete Foundation Base

Recommendations: Repair areas of cracking through the overall facility.

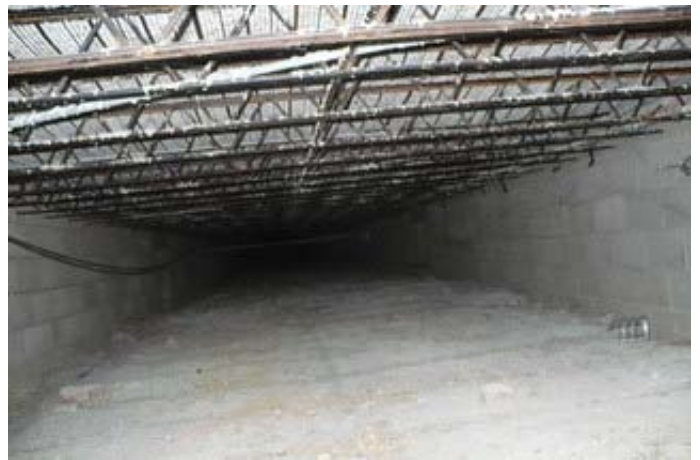
Crawl Space of the 1964 Addition

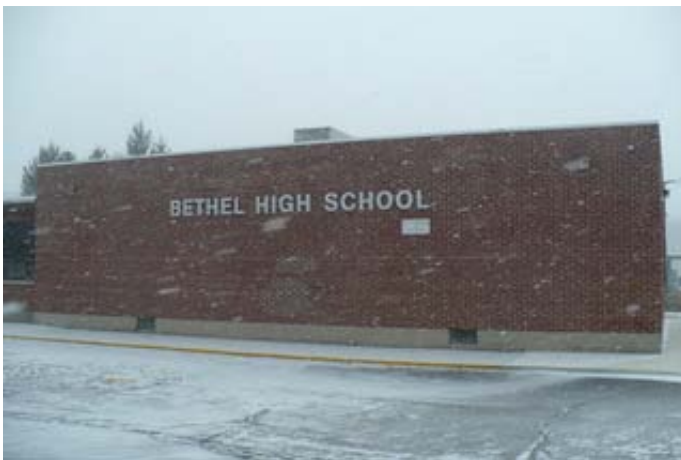
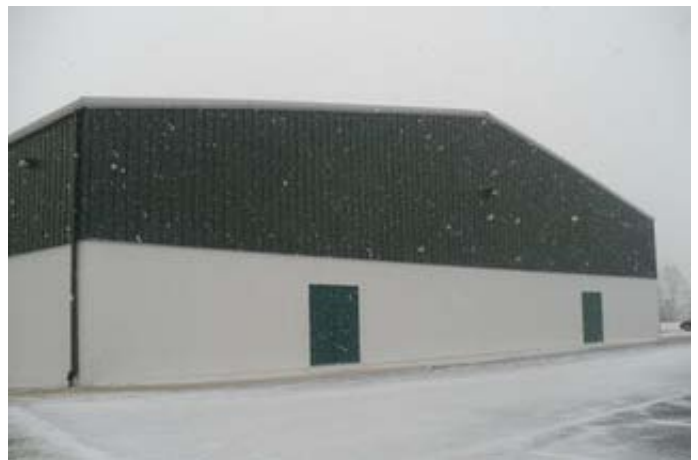
Description: The 1959 Original Construction and 1964 Addition have a brick veneer on load bearing masonry wall system, which displayed selective locations of deterioration, and is in fair condition. The 1999 Addition has concrete masonry units and steel siding on steel purlins in good condition. The 1959 Original Construction and 1964 Addition do not contain control or expansion joints and none are needed, as there is no indication of exterior masonry cracking or separation. The 1999 Addition appears to have appropriately spaced and inadequately caulked control joints in fair to poor condition. Exterior walls in the overall facility are inadequately insulated. Brick veneer masonry walls are cavity walls. Concrete masonry unit walls of the 1999 Addition are single-wythe construction. Weep holes are provided in the 1959 Original Construction and the 1964 Addition, but not in sufficient quantity at lintels, below sills, and the base of masonry cavity walls, and are in poor condition. Weep holes are rope type weeps and are plugged and ineffective. Vents are not provided. The exterior masonry has not been cleaned and sealed in recent years, and shows evidence of mortar deterioration in selective locations. Architectural exterior accent materials consist of metal siding and painted concrete masonry units, which are in good condition. Unit ventilators have been replaced. The grilles have been covered with solid sheet metal and should be replaced with masonry. Interior walls are concrete masonry units and glazed block and are in good to fair condition. Interior masonry appears to have adequately spaced and caulked control joints in good to fair condition. Interior soffits are of plaster type construction, and in good to fair condition. The window sills are stone, and are in fair condition. The exterior lintels are steel, and are in good to fair condition. There are no chimneys. Canopies over entrances are integral to the building construction, and are in good to fair condition. Exterior soffits are of plaster type and metal panel construction, and in good to fair condition. The school is not equipped with a loading dock.

Rating: 2 Needs Repair

Brick Masonry of the 1964 Addition

CMU and Metal Siding of the 1999 Addition

Recommendations: Provide tuckpointing in all areas of mortar deterioration as required through the overall facility. Provide masonry cleaning, sealing, and caulking as required through the overall facility. Sawcut and install new weeps at the base of wall, below window sills, and above doors and windows, and install new vents at the top of walls in the 1964 Addition. Repoint stone window sills in the 1964 Addition. Exterior wall insulation deficiencies are addressed in Item J. Infill existing unit ventilator openings in the 1964 Addition as required. Paint the exterior soffits and fascia of the 1964 Addition. All exterior work for the 1959 Original Construction is included in the Junior High Assessment.

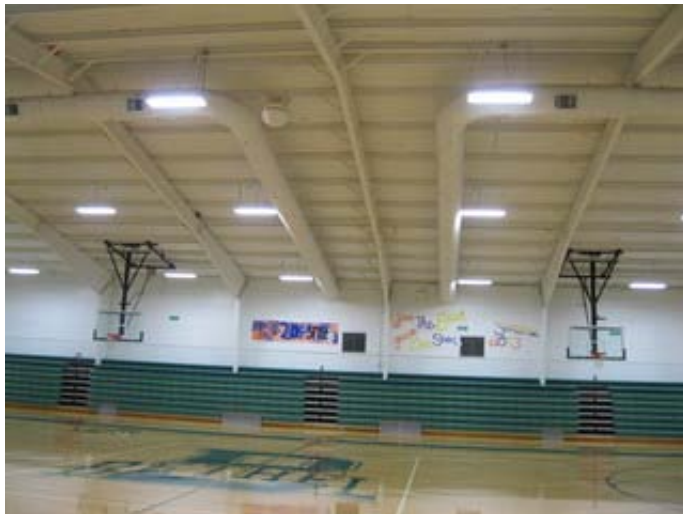
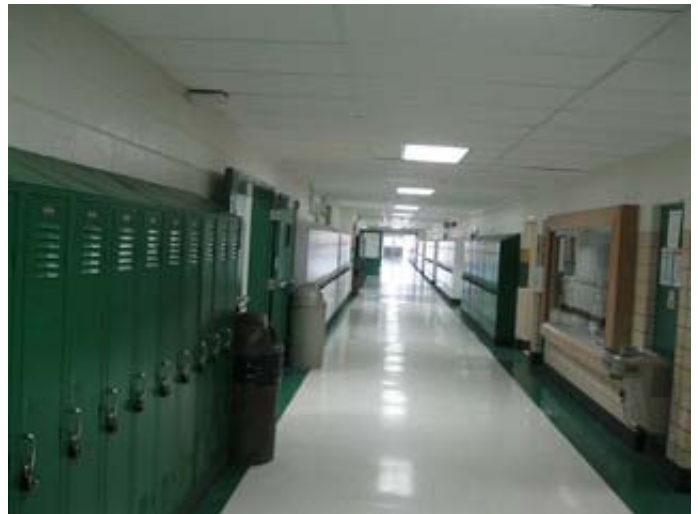
Gymnasium T-8 2x4 Suspended Fluorescent Light Fixtures

Corridor T-8 2x4 Lay-in Direct Fluorescent Light Fixtures

Recommendations: Provide complete replacement of lighting system due to age, condition, inadequate lighting levels, lack of multilevel switching, the utilization of incandescent fixtures, and installation of systems outlined in Items A, C, J, and U.

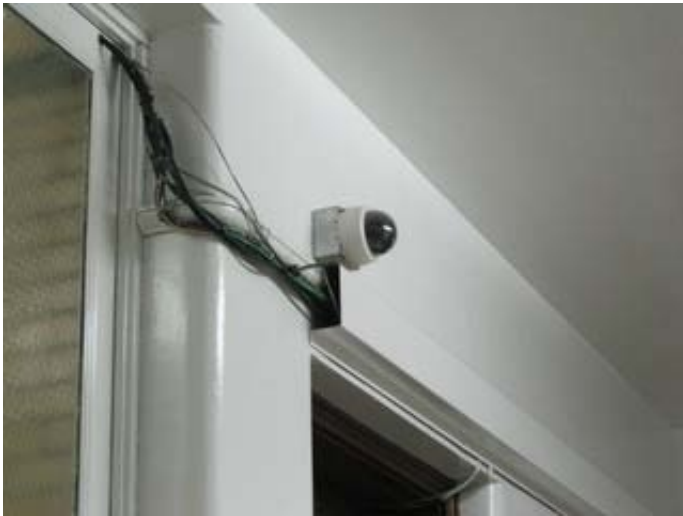
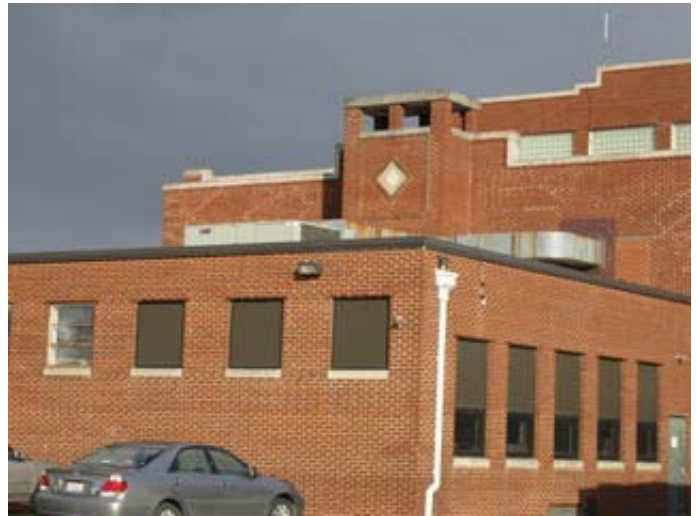
Security System CCTV Camera

Surface Mounted HID High Pressure Sodium Light Fixture

Recommendations: Provide complete replacement of security system to meet Ohio School Design Manual guidelines. Provide complete replacement of exterior site lighting system to meet Ohio School Design Manual guidelines.

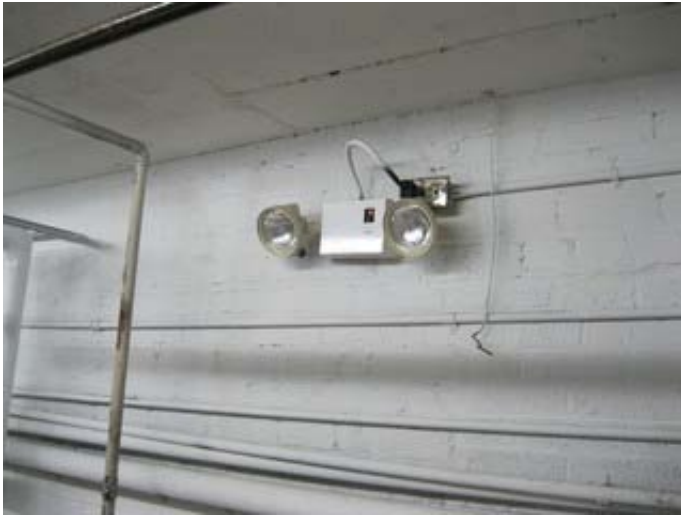
Non-Compliant Emergency Egress Light Fixture

Recommendations: Provide complete replacement of emergency / egress lighting system to meet Ohio School Design Manual guidelines.

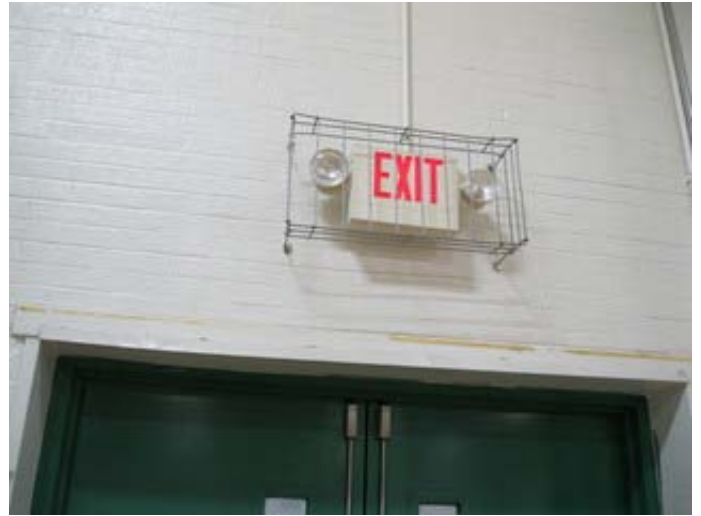
Non-Compliant Emergency Egress Light Fixture and Exit Sign

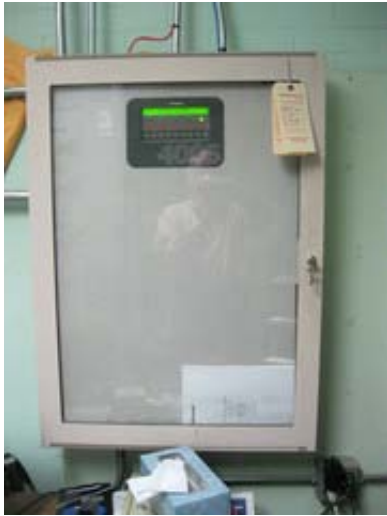
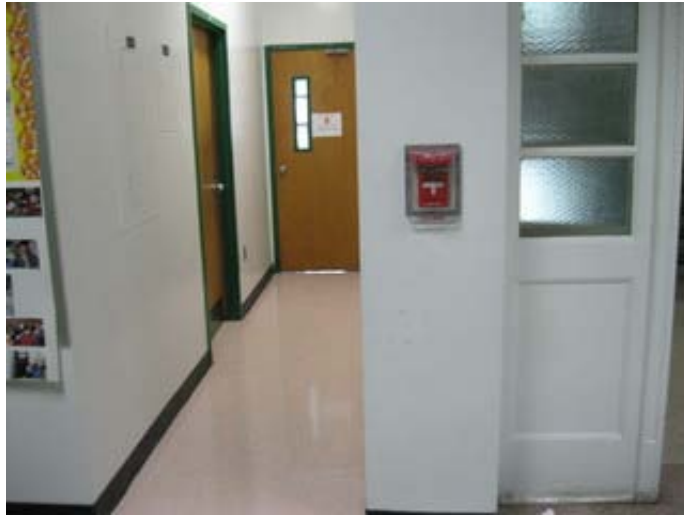
Fire Alarm System Control Panel

Fire Alarm System Manual Pull Station

Recommendations: Provide complete replacement of fire alarm system in the overall facility to meet OBC, NFPA, and Ohio School Design Manual guidelines.

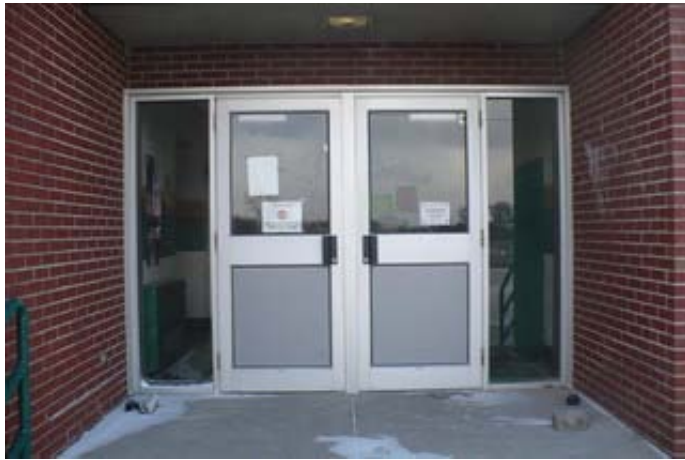
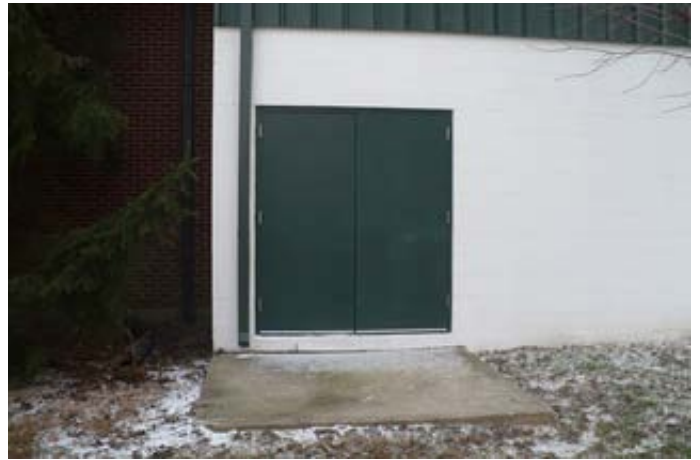
Entrance Doors of the 1964 Addition

Exterior Doors of the 1999 Addition

Recommendations: Replace all exterior doors and sidelights of the 1964 Addition to comply with Ohio Building Code, ADA, and Ohio School Design Manual guidelines, and due to condition.

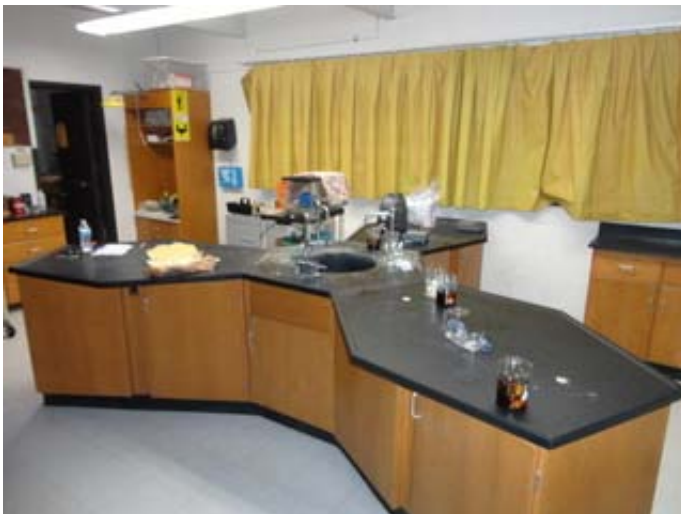
Asbestos Laboratory Tops

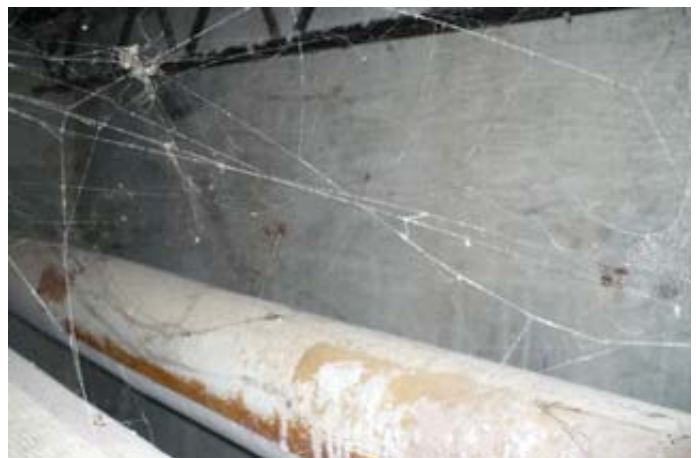
Asbestos Pipe Insulation
