Building Information - Bethel Local SD (48611) - Bethel Junior High

Program Type	Classroom Facilities Assistance Program (CFAP) - Regular
Setting	Rural
Assessment Name	Bethel Junior High (68080) FINAL - TPA Assessment with 2014 Costs
Assessment Date	2013-01-18
Cost Set:	2014
Building Name	Bethel Junior High
Building IRN	68080
Building Address	7490 S St Rt 201
Building City	Tipp City
Building Zipcode	45371
Building Phone	937.845.9430
Acreage	152.30
Current Grades:	7-8
Teaching Stations	8
Number of Floors	1
Student Capacity	196
Current Enrollment	177
Enrollment Date	2014-05-02

Bethel Junior High School, which is not on the National Register of Historic Buildings, and originally constructed in 1956, is a 1 story, 29,639 square foot brick school building located in a rural agricultural setting. The existing facility features a conventionally partitioned design, and does not utilize modular buildings. The structure of the overall facility contains brick veneer on a masonry bearing wall type exterior wall construction, with painted block and glazed block type wall construction in the interior. The floor system of the overall facility consists of concrete slab on steel joist type constr

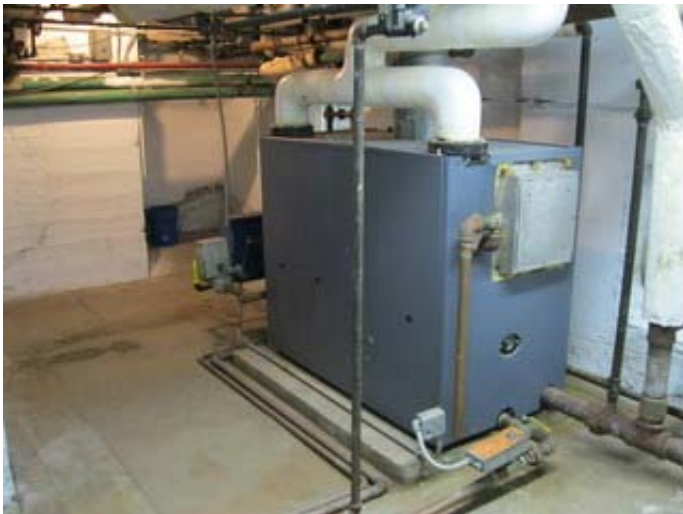
Description: The existing system for the 1956 Original Construction is a LP gas fired steam boiler type system, installed in 1956, and is in fair to poor condition. The existing systems for the 1959 and 1968 Additions are electric fired ducted VRF heat pump type system, installed in 2004, and are in good to fair condition. The heating system for the 1956 Original Construction is a 2-pipe steam and heated water type system, without a capacity for cooling operation, which is not compliant with the OSDM requirements for basic system type. These areas are not equipped with a central air conditioning system. The heating systems for the 1959 and 1968 Additions are electric fired ducted VFR heat pump type systems, with DX cooling. These systems are not 2 or 4-pipe systems with a capacity for simultaneous heating and cooling operation, which is not compliant with the OSDM requirements for basic system type. These areas are not equipped with a central air conditioning system. The one (1) steam Model 80 Series 1 boiler in the 1956 Original Construction, manufactured by Weil-McLain, was installed in 1980, and is in fair to poor condition. Steam is distributed to terminal units consisting of unit ventilators, cabinet heaters, fin tubes, air handlers, and unit heaters. The terminal equipment is original to each addition and is in fair to poor condition. The VRF heat pumps in the 1959 and 1968 Additions, manufactured by Mitsubishi, were installed in 2004 and are in good to fair condition. Heating forced air is distributed to terminal units consisting of Mitsubishi ceiling concealed indoor units/ducted fan coils. The terminal equipment was installed in 2004 and is in good to fair condition. The system does not comply with the 15 CFM per person fresh air requirements of the Ohio Building Code mechanical code and Ohio School Design Manual. The pneumatic and electric type system temperature controls are original to each addition, with incremental upgrades, and are in fair to poor condition. The system does not feature individual temperature controls in all spaces required by the OSDM. The overall system does not feature any central energy recovery systems. The overall facility is equipped with louvered interior doors to facilitate Corridor utilization as return air plenums. See Items J and O for replacement of doors. The existing systems in the 1959 and 1968 Additions are ducted, but the ductwork cannot be integrated into a possible future system due to arrangement, air volume, and routing of existing ductwork. The existing system in the remainder of the 1956 Original Construction is not ducted, and floor to structural deck heights will not accommodate the installation of properly sized ductwork for a future Ohio School Design Manual approved system. The overall heating system is evaluated as not being in safe and efficient working order, and long term life expectancy of the existing system is not anticipated. The structure is not equipped with a central air conditioning system. The site does not contain any underground fuel tanks.

Rating: 3 Needs Replacement

Weil-McLain LP Gas Fired Steam Boiler

Recommendations: Provide new overall heating, ventilating, and air conditioning system to achieve compliance with Ohio Building Code and Ohio School Design Manual standards. Replace the existing ductwork in the 1959 and 1968 Additions to facilitate efficient exchange of conditioned air with pricing included in conversion to ducted system replacement. Convert the 1956 Original Construction to a ducted system to facilitate efficient exchange of conditioned air. Provide architectural soffits in the 1956 Original Construction to accommodate the installation of ductwork, with funding provided in conversion to ducted system replacement.

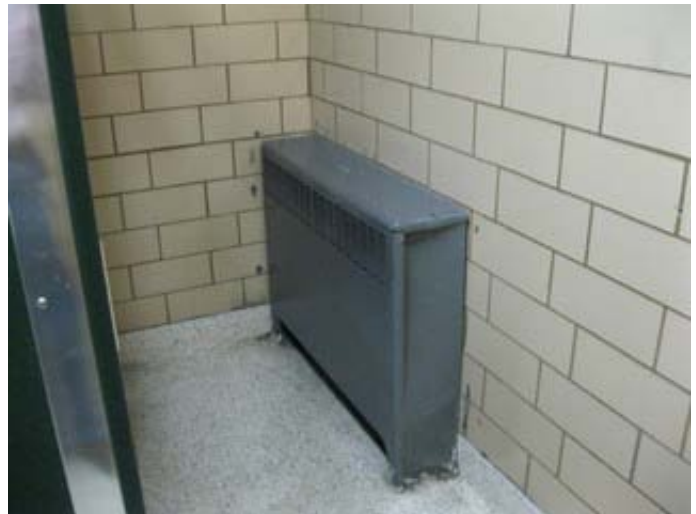
Fin Tube/Cabinet Heater

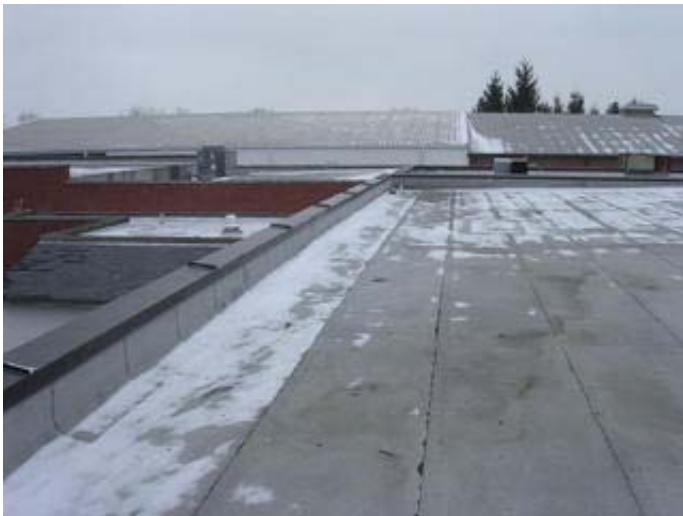
Description: The roof over the 1956 Original Construction is a built up roofing system that was installed in 1995, and is in fair condition. The roof over the 1959 Addition is a combination of a built up roofing system that was installed in 1990, that is in fair condition, and a galvanized standing seam metal roof system that was installed in 1999, that is in fair condition. The roof over the 1968 Addition is a built up roofing system that was installed in 1995, 1997, 1999, and 2002, and is in fair conditions. There is a small area of asphalt shingle roofing over the 1968 Addition that was installed at an unknown date, and is in poor condition. An infrared photographic and core sample survey of the roof was conducted in 2010 that indicates that there are areas of moisture damaged insulation at the areas of built up roofing. There are no District reports of current leaking. Minor signs of past leaking were observed during the physical assessment. Access to the roof was gained by a portable ladder. Provide roof access hatches / ladders as appropriate to facilitate access to all levels of low slope roof surfaces. Fall safety protection cages are not required. There were no observations of standing water on the roof. Metal cap flashings and stone copings are in fair condition. Roof storm drainage is addressed through a system of gutters and downspouts, roof drains, and through-wall scuppers, which are properly located, and in fair condition. The roof is not equipped with overflow roof drains though they are needed on this building. No problems requiring attention were encountered with any roof penetrations. There are not any covered walkways attached to this structure.

Rating: 3 Needs Replacement

Typical Built Up Roofing

Recommendations: The built up roofing systems over the 1956, 1959 and 1968 Additions require replacement to meet Ohio School Design Manual guidelines for age of system. Replace the asphalt shingles and provide vented nail base and insulation at the 1968 Addition. The standing seam metal roofing at the 1959 Addition requires no renovation or replacement at the present time. The flashing and coping areas of roof replacement on the 1956, 1959 and 1968 Additions require replacement with the roof replacements. Due to the scope of the roof replacement, gutters and downspouts require replacement. Overflow roof drains are required for the 1956 Original Construction and the 1968 Addition. Provide new roof insulation at areas of roof replacement. Provide roof access hatches / ladders as appropriate to facilitate access to all levels of low slope roof surfaces. Fall safety protection cages are not required.

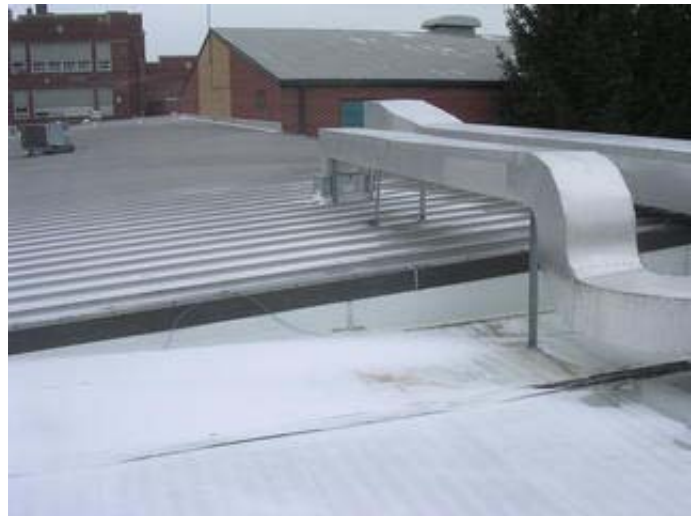
Typical Standing Seam Roofing

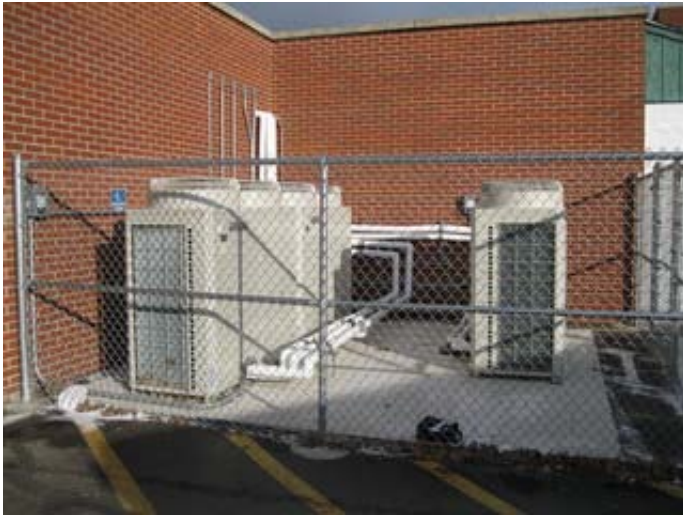
Description: The overall facility is not equipped with a central air conditioning system. Isolated room systems consisting of electric fired ducted VRF heat pump type systems, installed in 2004, and in good to fair condition, are provided throughout the 1959 and 1968 Additions. The ventilation system in the overall facility consists of unit ventilators, air handling units, and Mitsubishi concealed ceiling units/ducted fan coils, original to each addition, with incremental upgrades, and in fair to poor condition, providing fresh air to Classrooms, and other miscellaneous spaces such as the Gymnasium and Student Dining. Relief air venting is provided by louvered interior doors, unit ventilators, air handling units, concealed ceiling units/ducted fan coils, and central relief fans. The ventilation system does not meet the Ohio Building Code 15 CFM per occupant fresh air requirement. The overall system is not compliant with Ohio Building Code and Ohio School Design Manual requirements. Dust collection systems are not required in this facility. Exhaust systems for Restrooms, Storage Rooms, Custodial Closets, Maintenance Workrooms, and P.E. Workroom & Storage are inadequately placed, and in fair to poor condition. The Art Program is located in the High School.

Rating: 2 Needs Repair

Mitsubishi Heat Pump Condensing Units

Recommendations: Provide an air conditioning system to meet with Ohio Building Code and Ohio School Design Manual requirements. Pricing included in Item A. Replace the existing general building exhaust system.

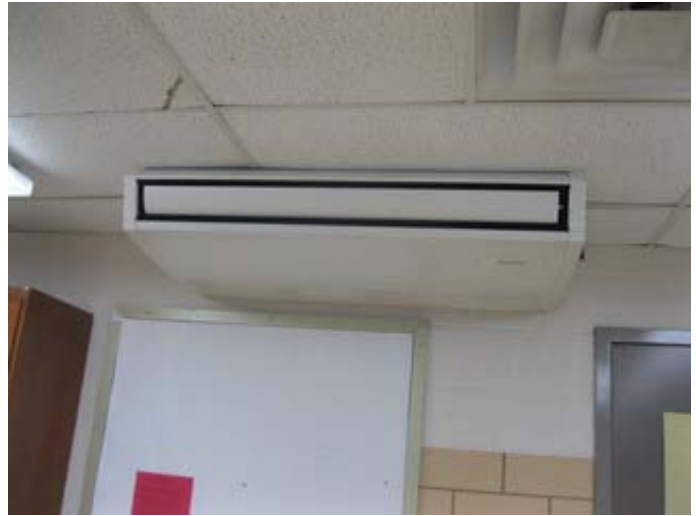
Mitsubishi Concealed Ceiling Unit

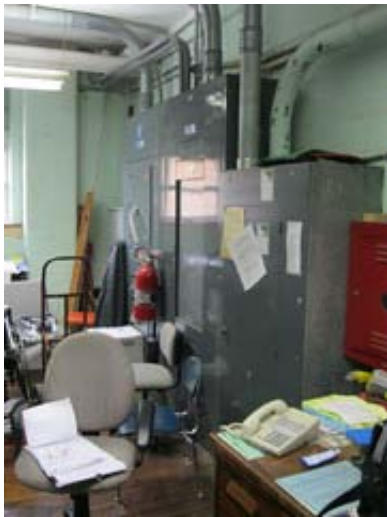
Description: The electrical system provided to the 1956 Original Construction is an extension of the 208Y/120vac volts, 2,000 amp, 3 phase and 4 wire system provided in the 1918 Original Construction of the Elementary School. The system was installed in 1968, with upgrades in 1993, and is in fair to poor condition. The systems in the 1959 and 1968 Additions are also an extension of that found in the 1918 Original Condition of the Elementary School. Power is provided to the school by a single utility-owned, pad-mounted transformer located outside the Mechanical Room in a wood and masonry enclosure, and is fair condition. The panel system installed in 1968, with upgrades in 1993, is in fair to poor condition, and cannot be expanded to add additional capacity. The Classrooms are not equipped with adequate electrical outlets. The typical Classroom contains four (4) general purpose outlets, zero (0) dedicated outlets for a group of three (3) Classroom computers, and zero (0) dedicated outlets for each Classroom television. Some Classrooms are equipped with as many as five (5) general purpose outlets, while others are equipped with as few as two (2) general purpose outlets. There are not any spaces that have no electrical outlets. The Corridors in the overall facility are equipped with adequate electrical outlets for servicing. Adequate GFI protected exterior outlets are not provided around the perimeter of the building. The facility is not equipped with an emergency generator. Adequate lightning protection safeguards are not provided. The Stage is located in the 1918 Auditorium Fixed Seating Addition of the Elementary School. The electrical systems in the overall facility, do not meet Ohio School Design Manual requirements in supporting the current needs of the school, and will be inadequate to meet the facility's future needs.

Rating: 3 Needs Replacement

Main Electrical Distribution Panel

Recommendations: The entire electrical system for the overall facility requires replacement to meet Ohio School Design Manual guidelines for overall capacity and Classroom capacity due to age, condition, lack of OSDM-required features, and to accommodate the replacement of the air conditioning system. Provide an emergency generator, with funding included in the electrical system replacement. Provide adequate lightning protection safeguards in the overall facility, including associated grounding system, with funding included in the electrical system replacement.

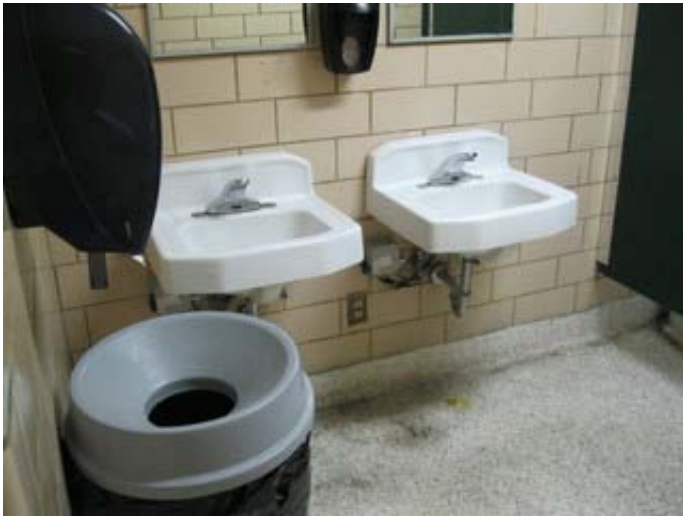
Description: The service entrance, located in the 1918 Original Construction of the Elementary School, is equipped with a 2 reduced pressure backflow preventers in good condition. The facility is equipped with a water treatment system located in the 1918 Original Construction of the Elementary School, and the system is in fair condition. The domestic water supply piping in the overall facility is galvanized and copper, is original to each addition, and is in fair to poor condition. The waste piping in the overall facility is cast iron and galvanized with some PVC, is original to each addition, and is in fair to poor condition. The water heater is located in the 1918 Original Condition of the Elementary School and is a 100 gallon AO Smith LP gas water heater, installed in 2011, in good condition, with a separate 350 gallon storage tank in poor condition. The overall facility is also equipped with roof top solar panels and a storage tank providing supplemental domestic heated water. The equipment was installed recently and is in good condition. The overall facility contains 2 Large Group Restrooms for boys, 2 Large Group Restrooms for girls, 1 Locker Room Restroom for boys, 1 Locker Room Restroom for girls, 1 Locker Room Restroom for staff, 0 Kitchen Restrooms, 1 Health Clinic Restroom, 0 Restrooms associated with Special Education Classrooms, and 1 Restroom for staff. Boys' Large Group Restrooms contain 2 ADA and 3 non-ADA floor mounted flush valve toilets, 2 ADA and 4 non-ADA floor mounted flush valve urinals, as well as 6 non-ADA wall mounted lavatories. Girls' Large Group Restrooms contain 2 ADA and 5 non-ADA floor mounted flush valve toilets, as well as 6 non-ADA wall mounted lavatories. Boys' Locker Room Restroom contains 2 non-ADA floor mounted flush valve toilets, 2 non-ADA floor mounted flush valve urinals, 2 non-ADA wall mounted lavatories, as well as 6 non-ADA showers. Girls' Locker Room Restroom contains 2 non-ADA floor mounted flush valve toilets, 2 non-ADA wall mounted lavatories, as well as 9 non-ADA showers. Staff Locker Room Restroom contains 1 non-ADA wall mounted flush valve toilet, 1 non-ADA wall mounted lavatory, as well as 1 non-ADA shower. Staff Restroom contains 1 non-ADA floor mounted flush valve toilet, as well as 1 non-ADA wall mounted lavatory. Condition of fixtures is fair to poor. The facility is equipped with 2 non-ADA electric water coolers, in fair condition. The Special Education Classroom is not equipped with the required Restroom. The Kitchen is not equipped with the required Restroom. The Health Clinic is equipped with the required Restroom which contains 1 non-ADA floor mounted flush valve toilet, as well as 1 non-ADA wall mounted lavatory, and fixtures are in fair condition. Due to existing grade configuration, there are no Kindergarten / Pre-K Classrooms. The Kitchen is located in the 1918 Original Construction of the Elementary School. The school meets the OBC requirements for fixtures and drinking fountains / electric water coolers. Per OBC and OSDM requirements this facility should be equipped with 10 toilets, 5 urinals, 10 lavatories, and 2 electric water coolers, and at present it is equipped with 18 toilets, 8 urinals, 18 lavatories, and 2 electric water coolers. ADA requirements are not met for fixtures and drinking fountains (see Item O). Custodial Closets are properly located and are adequately provided with required service sinks or floor drain sinks, which are in fair condition. Science Classroom / Lab utility sinks, gas connections, compressed air connections, and safety shower / eyewash are not provided. Due to existing grade configuration, no Biology or Chemistry Classroom acid waste systems are required. Adequate exterior wall hydrants are not provided.

Rating: 3 Needs Replacement

Non-ADA Wall Hung Lavatories

Recommendations: Replace water supply piping in the overall facility with copper piping due to age and condition. Replace sanitary waste piping in the overall facility due to age and condition. Due to age, condition, and OSFC standards, replace 18 lavatories, 18 toilets, 8 urinals, and 2 electric water coolers. See Item O for replacement of fixtures related to ADA requirements. Provide two (2) additional exterior wall hydrants. Provide Science Classroom / Lab with the required utility sinks. Provide Science Classroom / Lab with the required gas connections. Provide Science Classroom / Lab with the required compressed air connections. Provide Science Classroom / Lab with the required safety / eyewash stations.

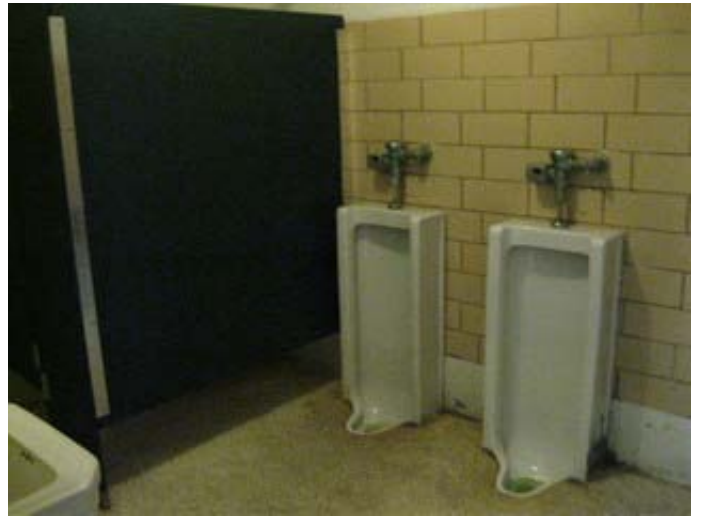
Non-ADA Floor Mount Flush Valve Urinals

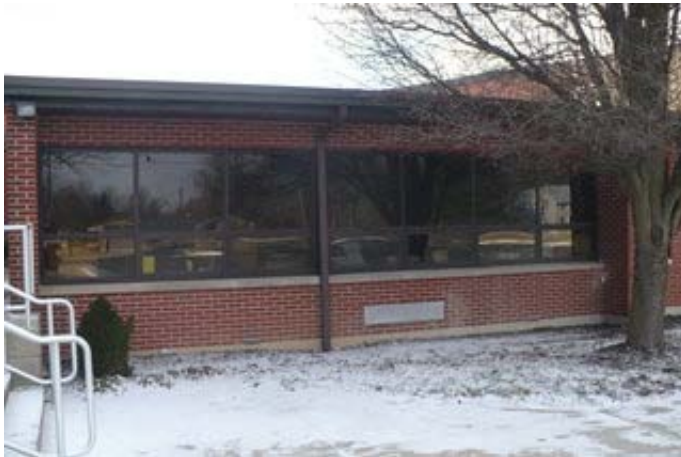
Description: The 1956 Original Construction is equipped with non-thermally broken steel frame windows with single glazed type window system, which was installed in 1956, and is in poor condition. The window system features inoperable windows throughout the building. Window system seals are in poor condition, with frequent air, but minimal water infiltration being experienced. Window system hardware is in fair condition. The window system features no blinds. The 1959 Addition is equipped with thermally broken aluminum frame windows with insulated glazing type window system, which was installed in 1987, and is in fair to poor condition. The window system features both operable and inoperable windows throughout the building, and operable windows are not equipped with opening limiters, or insect screens. Window system seals are in poor condition, with moderate air, but minimal water infiltration being experienced. Window system hardware is in fair condition. The window system features no blinds. The 1968 Addition is equipped with non-thermally broken aluminum frame windows with single glazed wire glass type clerestory window system in the Gymnasium, which is in poor condition and has been boarded up. This facility is not equipped with any curtain wall systems. This facility does not feature any glass block windows. The exterior doors in the overall facility are not equipped with sidelights and transoms, except for the main entrance to the 1959 Addition, which contains an all-aluminum and glass, single paned vestibule in fair condition. Exterior door vision panels in the 1959 Addition are single pane. Exterior door vision panels in the 1968 Addition are double glazed insulated glazing, in good condition. The school does not contain any skylights. The school does not contain any clerestories, with the exception of previous mention. Interior glass is OSDM-compliant. Window security grilles are not provided for ground floor windows. There is not a Greenhouse associated with this school.

Rating: 3 Needs Replacement

Typical Window of 1959 Addition

Recommendations: Provide a new insulated window system with integral blinds to meet with Ohio School Design Manual requirements and due to condition. Exterior door vision panel replacement and Vestibule deficiencies are addressed in Item S in exterior door replacement scope. Masonry infill for boarded up clerestory windows in 1968 Addition is addressed in Item H in Walls and Chimney scope.

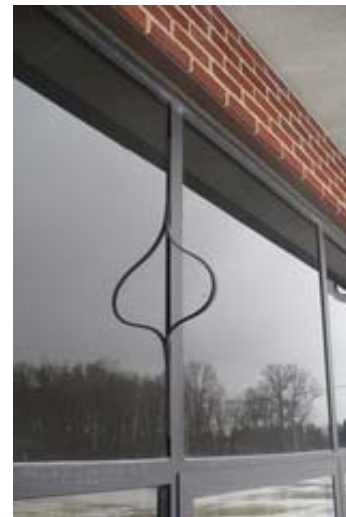
Poor Window Gasket in 1959 Addition

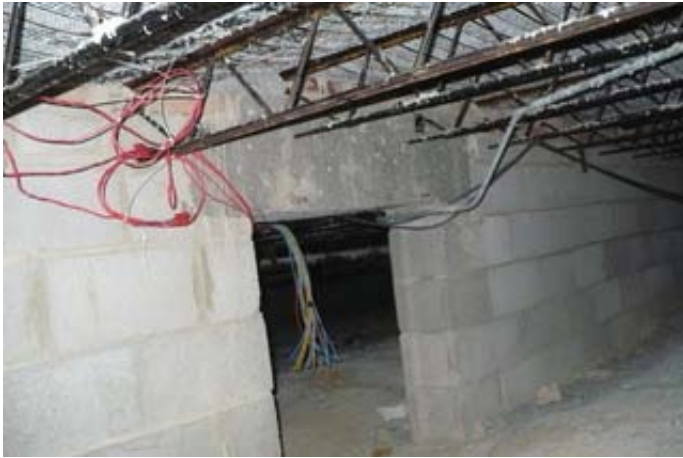
Description: The 1956 Original Construction has concrete masonry foundation walls, which displayed no locations of significant differential settlement, minimal cracking, no leaking, is in good to fair condition, and is slab on grade. The 1959 and 1968 Additions are equipped with concrete foundation walls on concrete footings, which displayed no locations of significant differential settlement, minimal cracking, no leaking, and are in good to fair condition. Most of the 1959 and 1968 Additions are on a crawl space, which is in good to fair condition. Areas of minor cracking were observed through the overall facility. The District reports that there has been no past leaking. No grading or site drainage deficiencies were noted around the perimeter of the structure that are contributing or could contribute to foundation / wall structural deterioration.

Rating: 2 Needs Repair

Crawl Space Under the 1959 Addition

Recommendations: Repair areas of cracking through the overall facility.

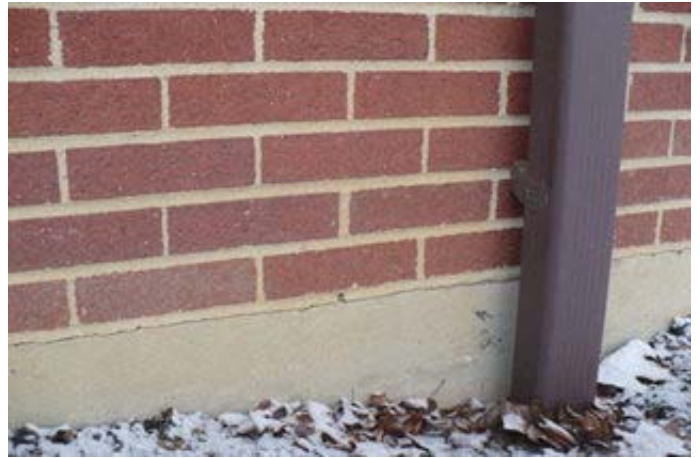
Typical Concrete Base Foundation Wall

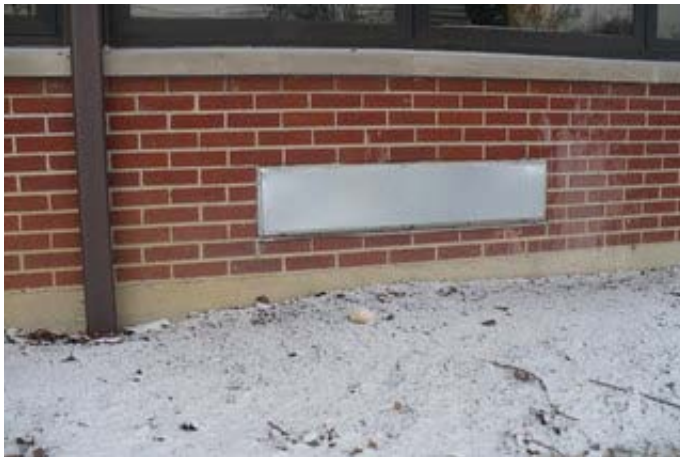
Description: The overall facility has a brick veneer on load bearing masonry wall system, which displayed locations of deterioration, and is in fair condition. The Gymnasium is constructed with a pre-engineered steel frame system and concrete masonry units, and is in fair condition. The school does not contain control or expansion joints and none are needed, as there is no indication of exterior masonry cracking or separation. Exterior walls in the overall facility are inadequately insulated. Brick veneer masonry walls are cavity walls. Weep holes are provided, but not in sufficient quantity at lintels, below sills, and the base of masonry cavity walls, and are in poor condition. Weep holes are rope type weeps and are plugged and ineffective. Vents are not provided. The exterior masonry has not been cleaned and sealed in recent years, and shows evidence of mortar deterioration in selective locations. Architectural exterior accent materials consist of minimal contrasting brick which is in fair condition. Unit ventilators have previously been replaced, and the openings have been covered with solid sheet metal and should be replaced with masonry. Interior walls are concrete masonry units and glazed block and are in good to fair condition. Interior masonry appears to have adequately spaced and caulked control joints in good to fair condition. Interior soffits are of plaster type construction, and in good to fair condition. The window sills are stone, and are in fair condition. The exterior lintels are steel, and are in fair condition. There are no chimneys. Canopies over entrances are integral to the building construction, and are in good to fair condition. Exterior soffits are of plaster type and metal panel construction, and in good to fair condition. The school is not equipped with a loading dock.

Rating: 2 Needs Repair

Typical Unit Ventilator Opening in 1959 Addition

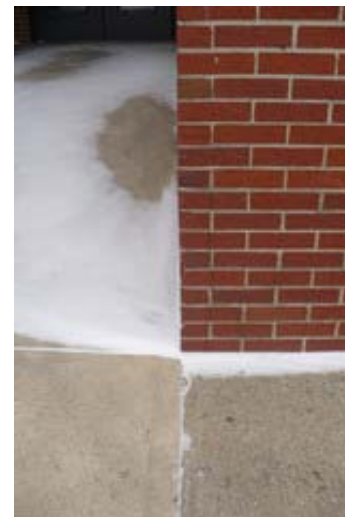
Minor Cracking in 1969 Addition

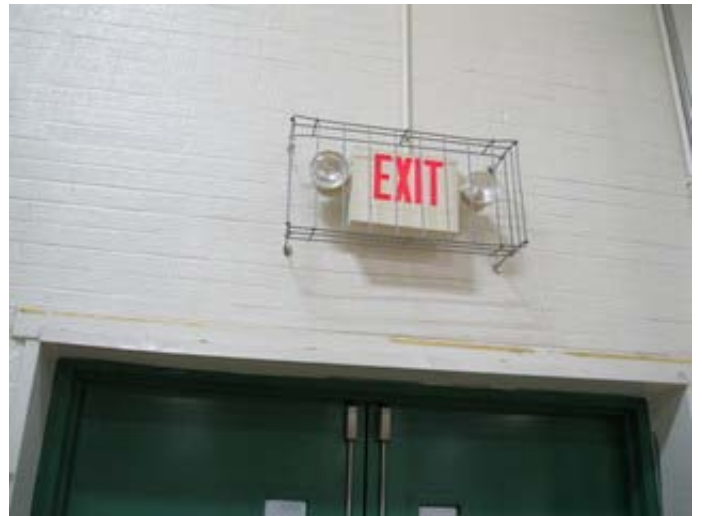
Rating: 3 Needs Replacement

Non-Compliant Emergency Egress Light Fixture and Exit Sign

Recommendations: Provide complete replacement of emergency / egress lighting system to meet Ohio School Design Manual guidelines.

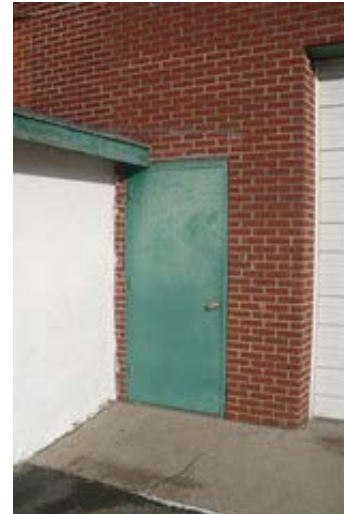
Exterior Door of 1956 Original Construction

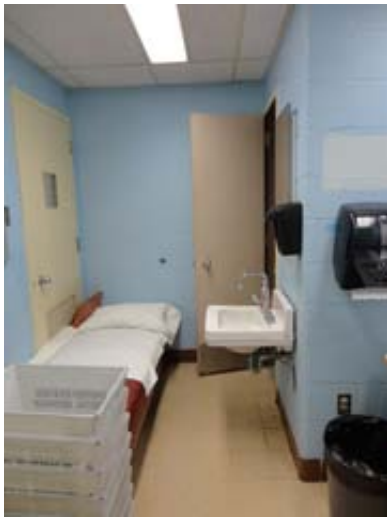
VAT in Clinic

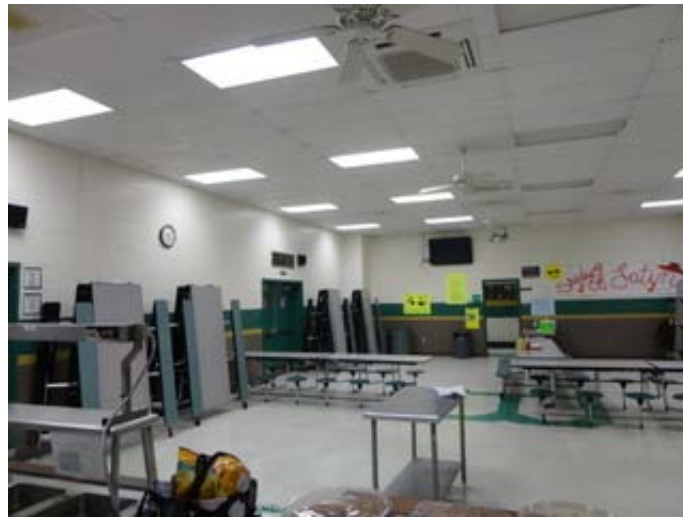
Acoustical Panels in Student Dining
