Building Information - Bethel Local SD (48611) - Bethel High

Program Type	Classroom Facilities Assistance Program (CFAP) - Regular
Setting	Rural
Assessment Name	Bethel High (2576) FINAL - TPA Assessment with 2014 Costs
Assessment Date	2013-01-18
Cost Set:	2014
Building Name	Bethel High
Building IRN	2576
Building Address	7490 S St Rt 201
Building City	Tipp City
Building Zipcode	45371
Building Phone	937.845.9487
Acreage	152.30
Current Grades:	9-12
Teaching Stations	25
Number of Floors	1
Student Capacity	154
Current Enrollment	271
Enrollment Date	2014-05-02

GENERAL DESCRIPTION

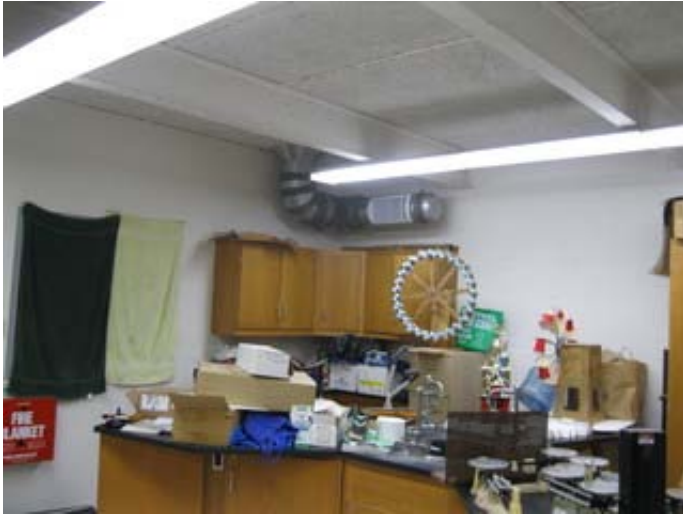
Typical 1964 Addition Steel Roof Framing and Tectum Panel Roof Construction

Recommendations: Existing conditions require no renovation or replacement at the present time.

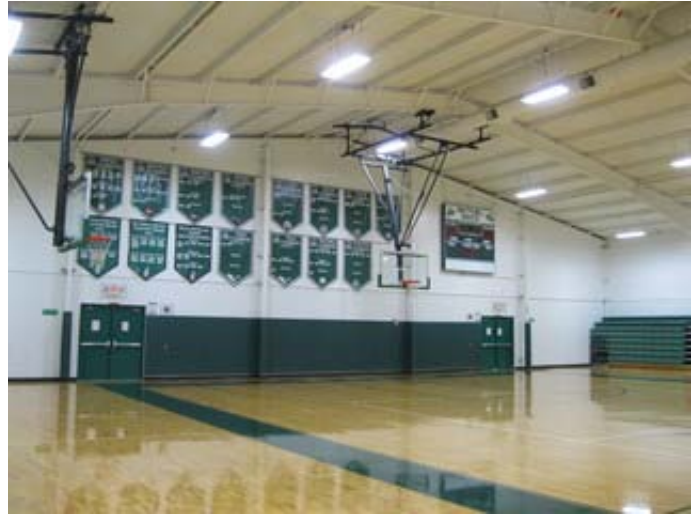
Typical 1999 Addition Steel Frame and Tectum Deck Construction

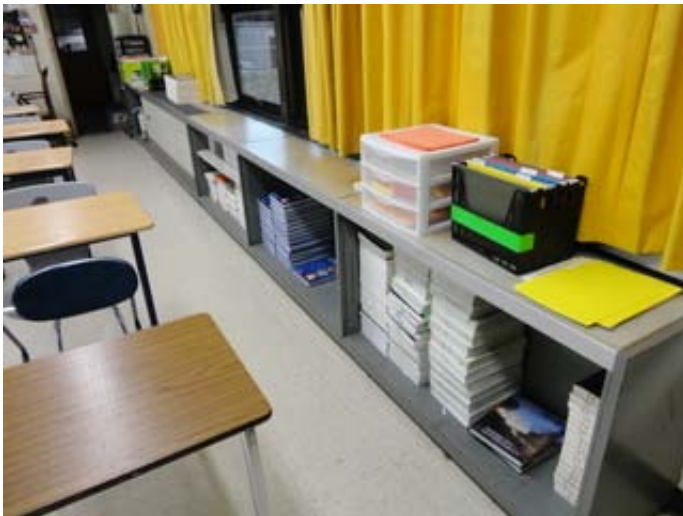
Classroom Casework

Item	Cost	Unit	Whole Building	Original Construction (1959) 790 ft ²	Classroom Addition (1964) 13,844 ft ²	Gymnasium Addition (1999) 13,134 ft ²	Sum	Comments
Complete Replacement of Finishes and Casework (High):	\$17.70	sq.ft.		Required	Required		\$259,021.80	(high school, per building area, with removal of existing)
Toilet Partitions:	\$1,000.00	per stall			6 Required		\$6,000.00	(removing and replacing)
Toilet Accessory Replacement	\$0.20	sq.ft.			Required		\$2,768.80	(per building area)
Door, Frame, and Hardware:	\$1,300.00	each		3 Required	16 Required		\$24,700.00	(non-ADA)
Additional Wall Insulation	\$6.00	sq.ft. (Qty)			6,843 Required	3,809 Required	\$63,912.00	(includes the furring out of the existing walls, insulation and abuse resistant GWB)
Laboratory Table / Countertop Replacement	\$150.00	ln.ft.			10 Required		\$1,500.00	(Hazardous Material Replacement Cost - See T.)
Other: Cement Board Replacement	\$14.60	sq.ft. (Qty)			800 Required		\$11,680.00	Provide for the replacement of cement board soffits due to work in Item T.

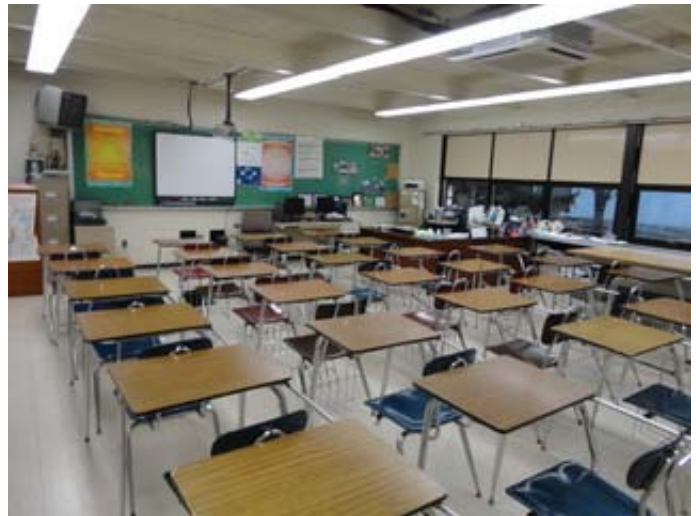
Typical Classroom Finishes

Other: Provide Acoustical Wall Treatment	\$3.00	sq.ft. (Qty)			3,500 Required	1,500 Required	\$15,000.00	Provide sound attenuation due to being inadequately provided.
Sum:			\$384,582.60	\$17,883.00	\$339,345.60	\$27,354.00

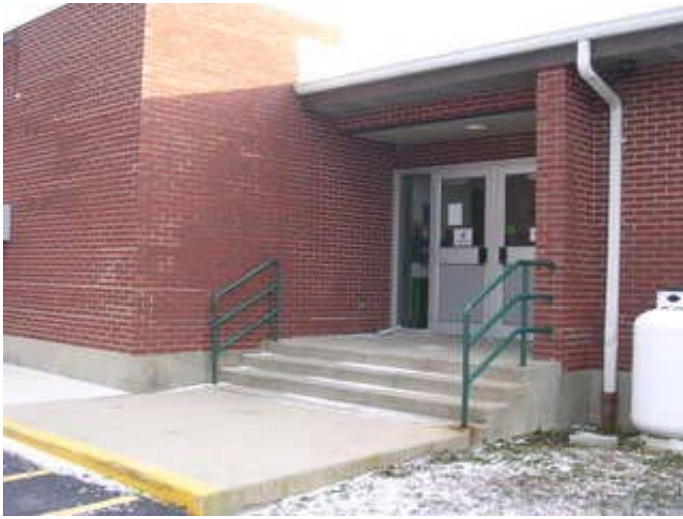
High School Entry

Item	Cost	Unit	Whole Building	Original Construction (1959) 790 ft²	Classroom Addition (1964) 13,844 ft²	Gymnasium Addition (1999) 13,134 ft²	Sum	Comments
Signage:	\$0.20	sq.ft.		Required	Required	Required	\$5,553.60	(per building area)
Ramps:	\$40.00	sq.ft. (Qty)			98 Required		\$3,920.00	(per ramp/interior-exterior complete)
Electric Water Coolers:	\$3,000.00	unit			2 Required		\$6,000.00	(new double ADA)
Toilet/Urinals/Sinks:	\$3,800.00	unit			16 Required		\$60,800.00	(new ADA)
Toilet/Urinals/Sinks:	\$1,500.00	unit			6 Required		\$9,000.00	(replacement ADA)
ADA Assist Door & Frame:	\$7,500.00	unit			1 Required		\$7,500.00	(openers, electrical, patching, etc)
Remount Restroom Mirrors to Handicapped Height:	\$285.00	per restroom			3 Required		\$855.00	
Provide ADA Shower:	\$3,000.00	each			4 Required		\$12,000.00	(includes fixtures, walls, floor drain, and supply line of an existing locker room)
Provide Toilet Accessories:	\$1,000.00	per restroom			6 Required		\$6,000.00

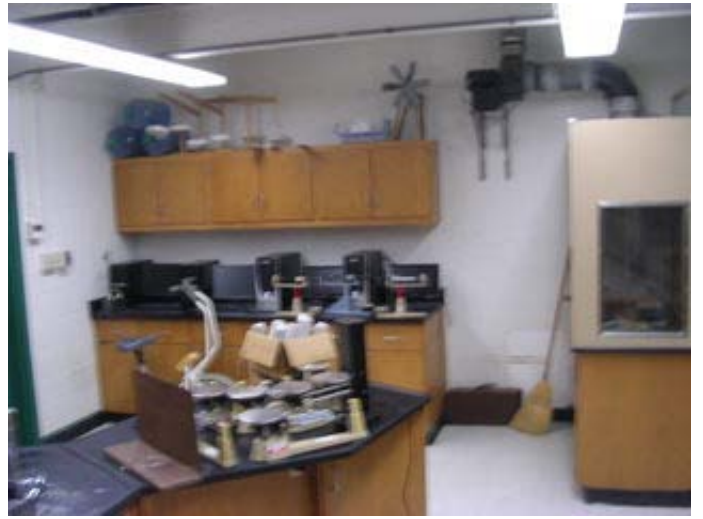
Sciences Lab Work Station and Sink

Other: ADA Pipe Wrap Insulation	\$50.00	each			3 Required		\$150.00	Provide pipe wrap insulation guards at sinks.
Other: Add ADA Unisex Restroom	\$10,000.00	each		2 Required			\$20,000.00	Add ADA compliant unisex toilet room.
Sum:			\$131,778.60	\$20,158.00	\$108,993.80	\$2,626.80

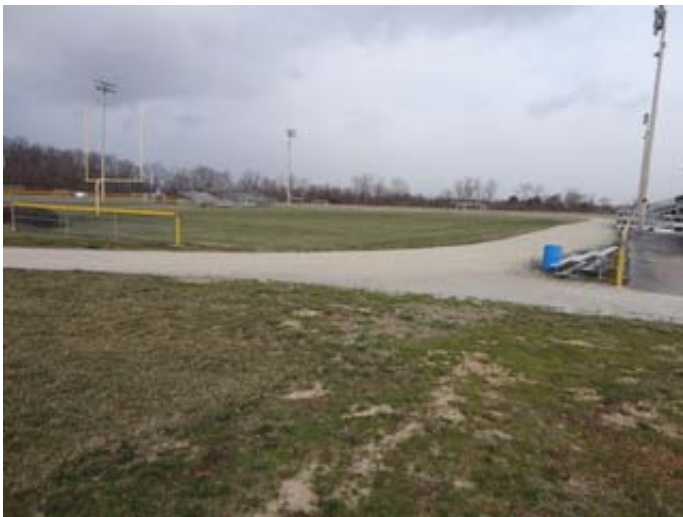
Football Field and Track

Item	Cost	Unit	Whole Building	Original Construction (1959)	Classroom Addition (1964)	Gymnasium Addition (1999)	Sum	Comments
				790 ft ²	13,844 ft ²	13,134 ft ²		
New Asphalt Paving (light duty):	\$25.80	sq. yard		108 Required	1,800 Required	1,692 Required	\$92,880.00	
Bus Drop-Off for High	\$68.75	per student		5 Required	70 Required	67 Required	\$9,762.50	(Number of students should be rounded up to the nearest 100. \$5500 per bus; 40 students per bus; 50% of high school students riding)
Concrete Curb:	\$18.00	l.n.ft.		108 Required	1,800 Required	1,692 Required	\$64,800.00	(new)
Concrete Sidewalk:	\$4.69	sq.ft. (Qty)		30 Required	500 Required	470 Required	\$4,690.00	(5 inch exterior slab)
Base Sitework Allowance for Unforeseen Circumstances	\$50,000.00	allowance			Required		\$50,000.00	Include this and one of the next two. (Applies for whole building, so only one addition should have this item)

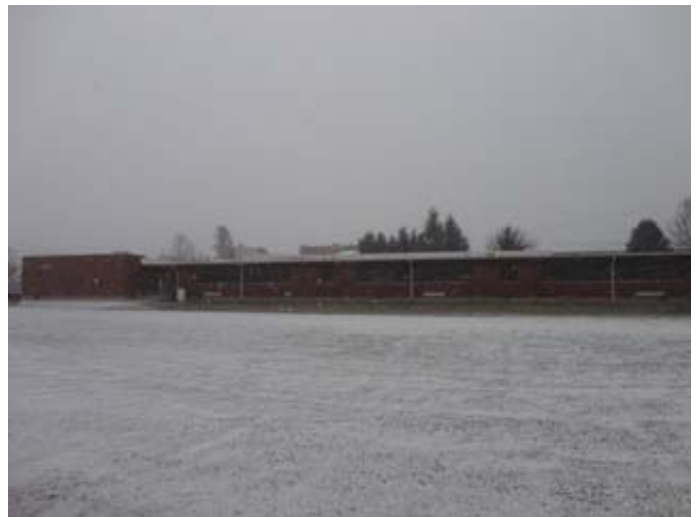
Gravel Parking Lot

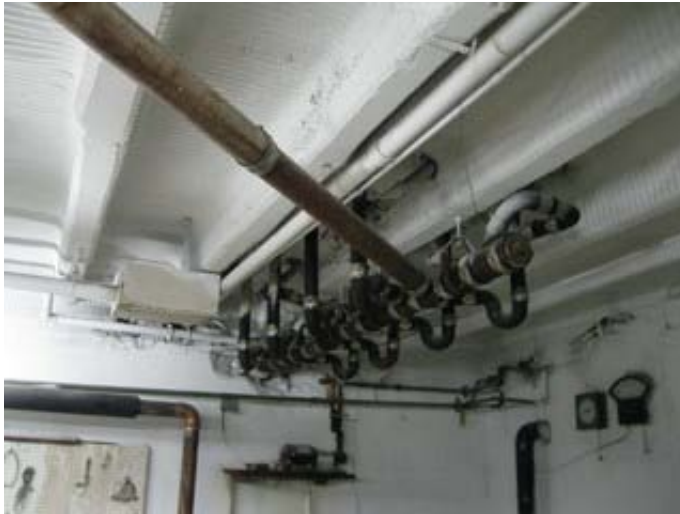
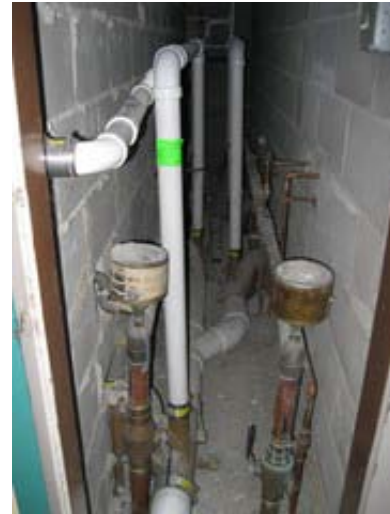
Sanitary Waste Lines

Recommendations: Existing conditions require no renovation or replacement at the present time.

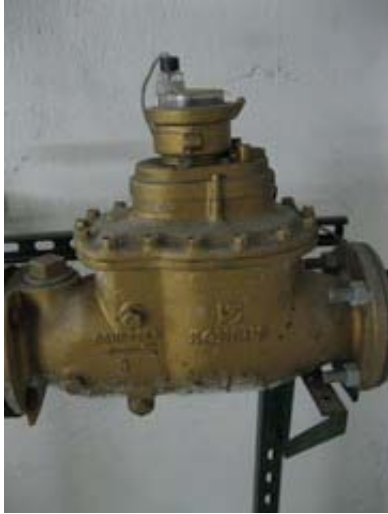
Incoming Domestic Water Service Meter

Recommendations: Provide a new city water supply line of adequate capacity to support the existing needs of the facility, as well as a future automated fire suppression system. Funding provided in Item U.

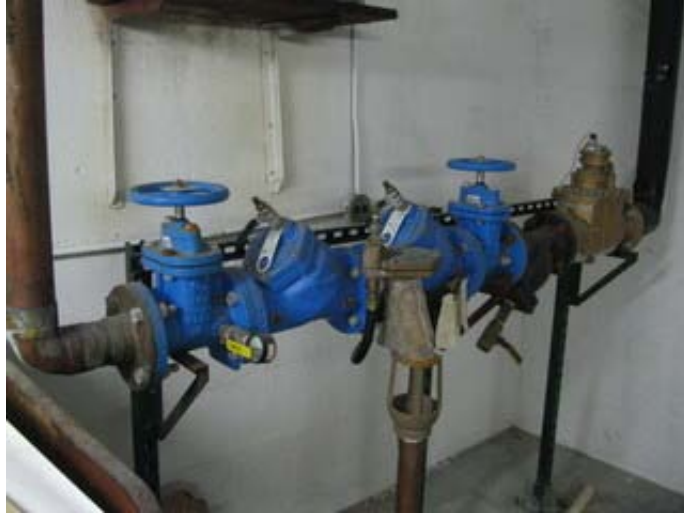
Incoming Domestic Water Service Line and Backflow Preventers

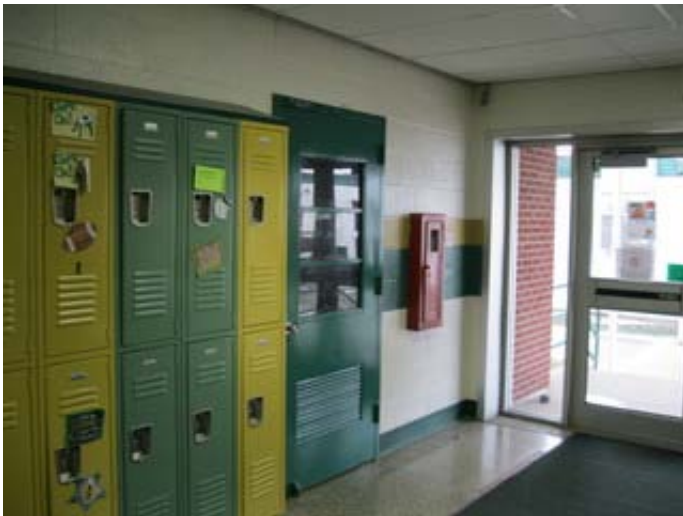
Typical Fire Extinguisher Cabinets

Recommendations: Provide new automated fire suppression system to meet Ohio School Design Manual guidelines. Provide increased water service of a capacity sufficient to support the fire suppression system, funding included in fire suppression funding. Provide new emergency generator, with funding provided via complete replacement of electrical system in Item D.

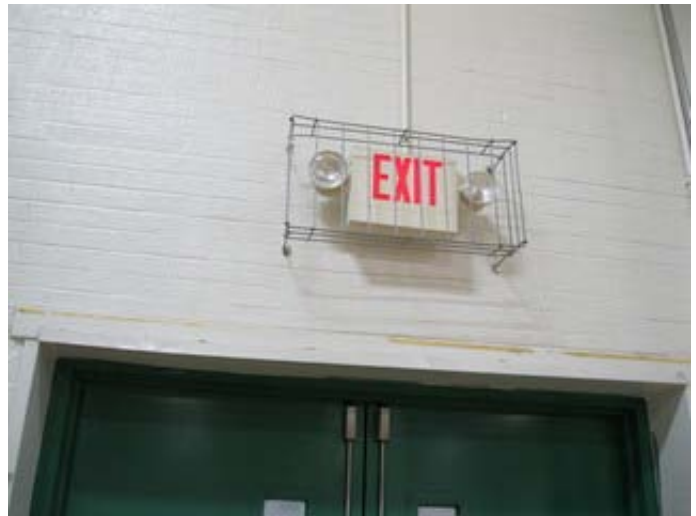
Typical Exit Lighting Signage

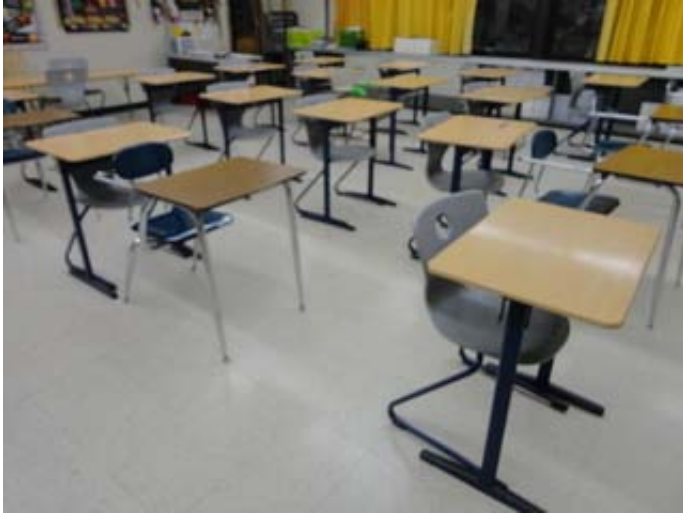
Student Desks and Chairs

Recommendations: Provide for replacement of outdated or inadequate furnishings.

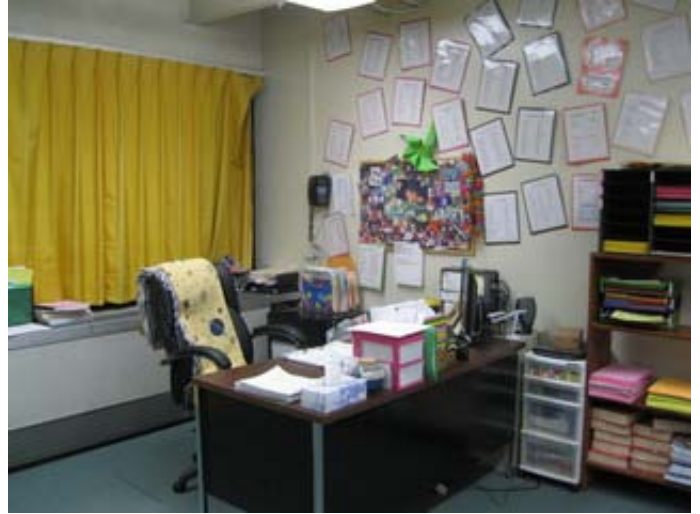
Teacher Desk and Chair

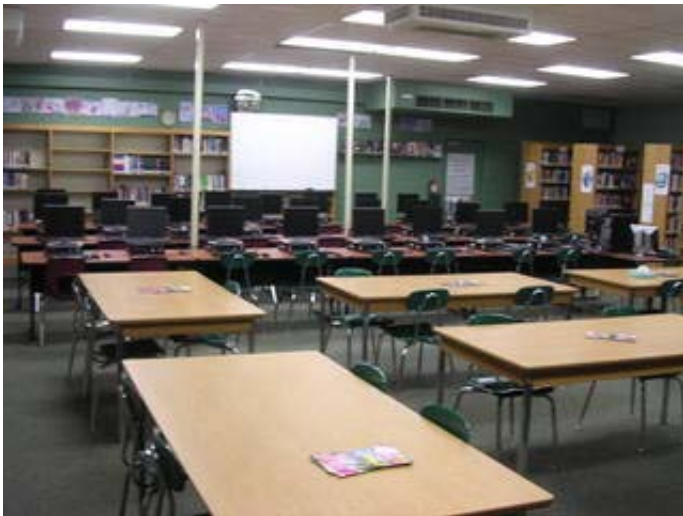
Computer Lab

Recommendations: Provide complete replacement of technology systems to meet Ohio School Design Manual requirements, and to sustain the capacity to keep pace with technological development. Provide a compliant centralized clock system.

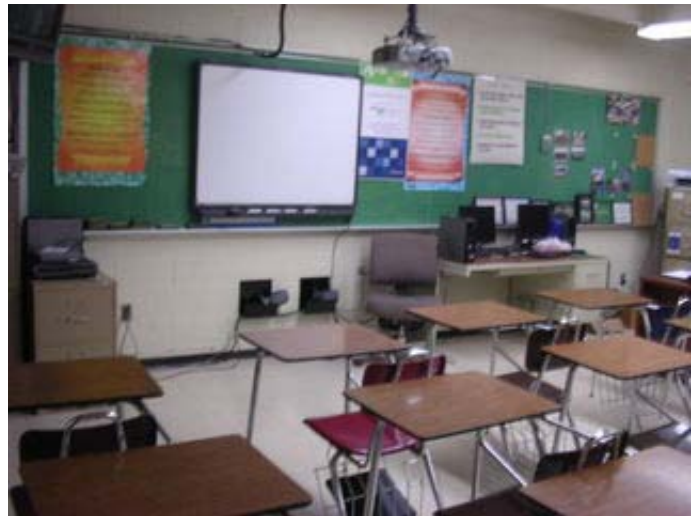
Typical Smart Board and Student Computer Workstations
