Building Information - Bethel Local SD (48611) - Bethel Junior High

Program Type	Classroom Facilities Assistance Program (CFAP) - Regular
Setting	Rural
Assessment Name	Bethel Junior High (68080) FINAL - TPA Assessment with 2014 Costs
Assessment Date	2013-01-18
Cost Set:	2014
Building Name	Bethel Junior High
Building IRN	68080
Building Address	7490 S St Rt 201
Building City	Tipp City
Building Zipcode	45371
Building Phone	937.845.9430
Acreage	152.30
Current Grades:	7-8
Teaching Stations	8
Number of Floors	1
Student Capacity	196
Current Enrollment	177
Enrollment Date	2014-05-02

Bethel Junior High School, which is not on the National Register of Historic Buildings, and originally constructed in 1956, is a 1 story, 29,639 square foot brick school building located in a rural agricultural setting. The existing facility features a conventionally partitioned design, and does not utilize modular buildings. The structure of the overall facility contains brick veneer on a masonry bearing wall type exterior wall construction, with painted block and glazed block type wall construction in the interior. The floor system of the overall facility consists of concrete slab on steel joist type constr

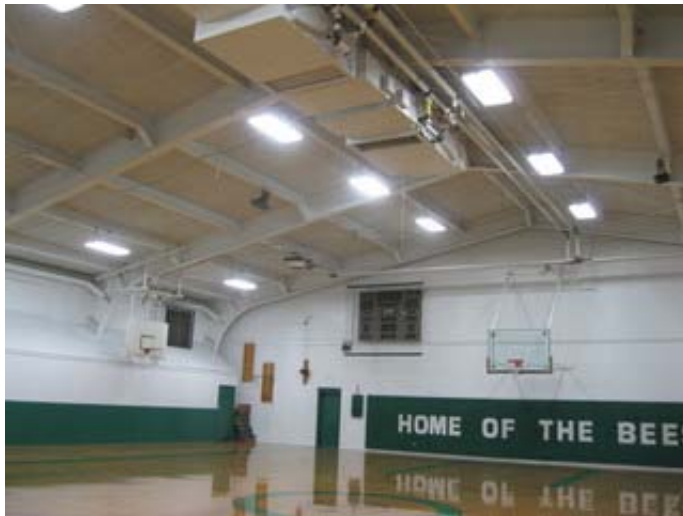
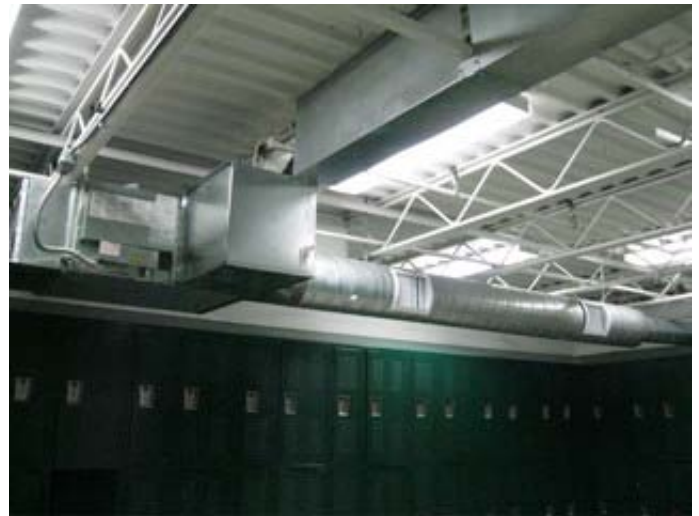
Steel Frame and Tectum Panel Roof Cconstruction at Middle School Gymnasium

Typical Steel Joist and Tectum Deck Construction in the 1959 Addition

Recommendations: Existing conditions require no renovation or replacement at the present time.

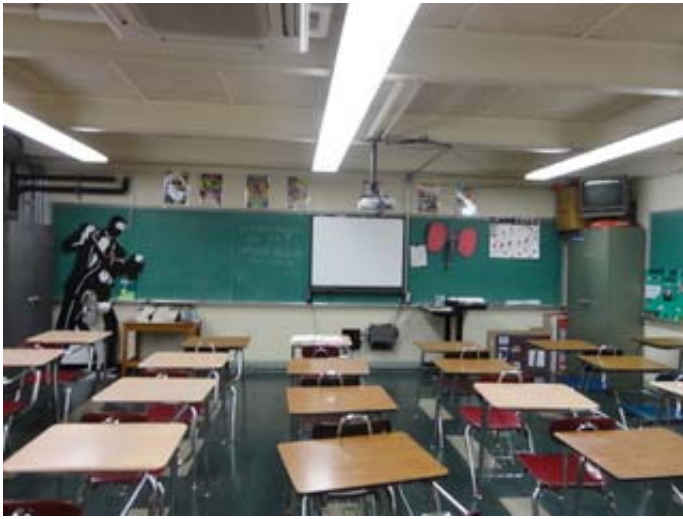
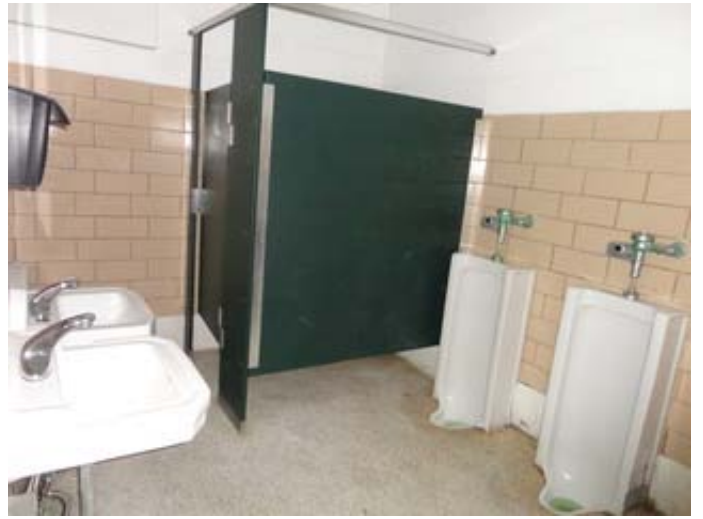
Typical Classroom Finishes

Typical Restroom Finishes

Item	Cost	Unit	Whole Building	Original Construction (1956) 2,343 ft ²	Classroom Addition (1959) 19,927 ft ²	Classroom Addition (1968) 7,369 ft ²	Sum	Comments
Complete Replacement of Finishes and Casework (Middle):	\$15.90	sq.ft.		Required	Required	Required	\$471,260.10	(middle, per building area, with removal of existing)
Toilet Accessory Replacement	\$0.20	sq.ft.		Required	Required	Required	\$5,927.80	(per building area)
Door, Frame, and Hardware:	\$1,300.00	each		2 Required	15 Required	10 Required	\$35,100.00	(non-ADA)
Resilient Wood/Synthetic Flooring	\$12.85	sq.ft. (Qty)			8,586 Required		\$110,330.10	(tear-out and replace per area)
Basketball Backboard Replacement	\$3,200.00	each			4 Required		\$12,800.00	(non-electric)
Additional Wall Insulation	\$6.00	sq.ft. (Qty)		425 Required	3,648 Required	7,195 Required	\$67,608.00	(includes the furring out of the existing walls, insulation and abuse resistant GWB)

Other: Provide sound attenuation.	\$3.00	sq.ft. (Qty)			3,435 Required	1,560 Required	\$14,985.00	Provide acoustical surface treatment at Gymnasium, Student Dining, Media Center, and Music spaces.
Sum:			\$718,011.00	\$42,872.30	\$495,647.80	\$179,490.90

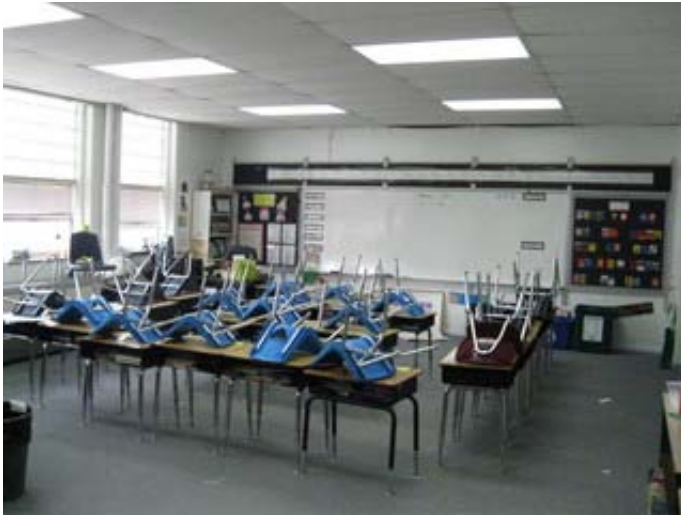
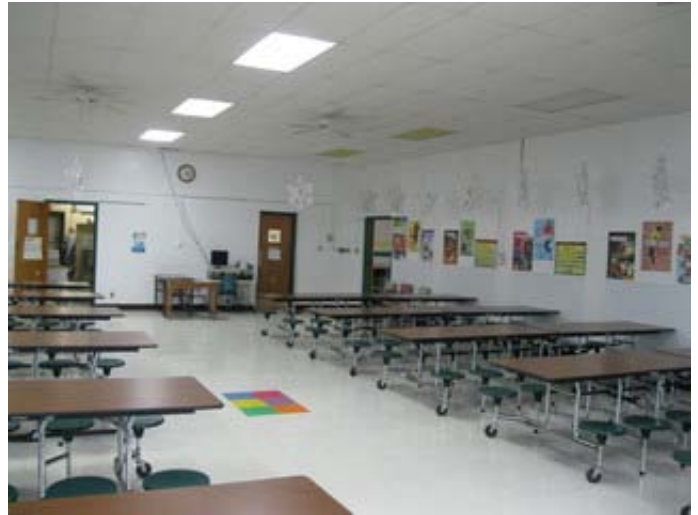
Classroom T-8 2x4 Lay-in Direct Fluorescent Light Fixtures

Student Dining T-8 2x4 Lay-in Direct Fluorescent Light Fixtures

Provide complete replacement of lighting system due to age, condition, inadequate lighting levels, lack of multilevel switching, the utilization of incandescent fixtures, and installation of systems outlined in Items A, C, J, and U.

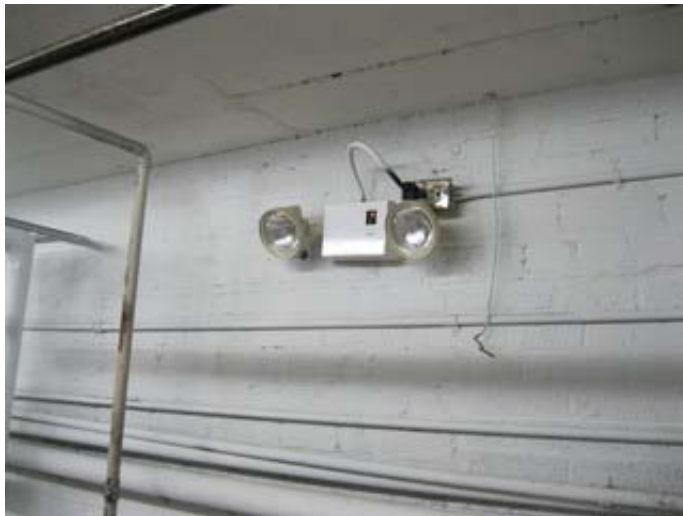
Surface Mount Emergency Egress Light Fixture

Recommendations: Provide complete replacement of emergency / egress lighting system to meet Ohio School Design Manual guidelines.

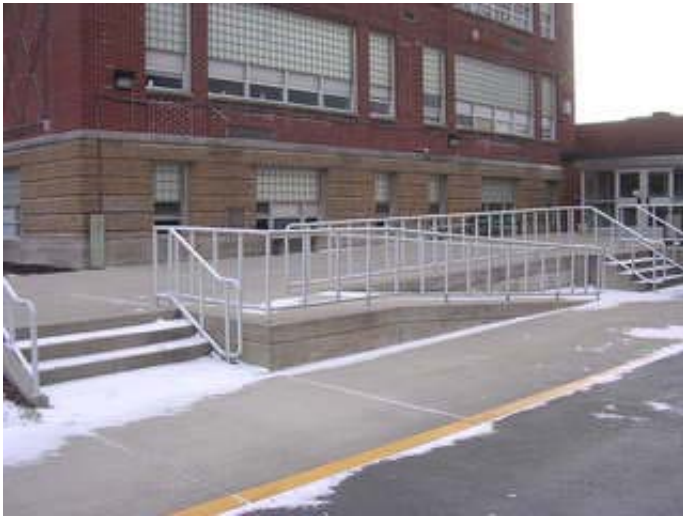
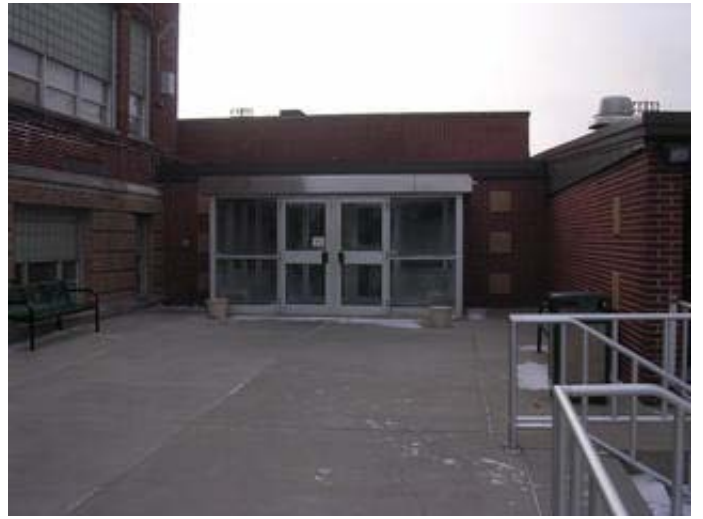
Ramp From Parking to Main Entry

Main Entry

Item	Cost	Unit	Whole Building	Original Construction (1956) 2,343 ft²	Classroom Addition (1959) 19,927 ft²	Classroom Addition (1968) 7,369 ft²	Sum	Comments
Signage:	\$0.20	sq.ft.		Required	Required	Required	\$5,927.80	(per building area)
Ramps:	\$40.00	sq.ft. (Qty)			360 Required		\$14,400.00	(per ramp/interior-exterior complete)
Electric Water Coolers:	\$3,000.00	unit			1 Required	1 Required	\$6,000.00	(new double ADA)
Toilet/Urinals/Sinks:	\$1,500.00	unit			10 Required	4 Required	\$21,000.00	(replacement ADA)
Toilet Partitions:	\$1,000.00	stall			2 Required	2 Required	\$4,000.00	(ADA - grab bars, accessories included)
ADA Assist Door & Frame:	\$7,500.00	unit			1 Required	1 Required	\$15,000.00	(openers, electrical, patching, etc)
Remount Restroom Mirrors to Handicapped Height:	\$285.00	per restroom			6 Required	3 Required	\$2,565.00	
Provide ADA Shower:	\$3,000.00	each			4 Required		\$12,000.00	(includes fixtures, walls, floor drain, and supply line of an existing locker room)

Provide Toilet Accessories:	\$1,000.00	per restroom			6 Required		\$6,000.00	
Other: ADA Pipe Wrap Insulation	\$50.00	each			5 Required	3 Required	\$400.00	Provide pipe wrap insulation guards at sinks.
Other: ADA-compliant grab bars	\$45.00	each			2 Required	2 Required	\$180.00	Provide vertical grab bars at existing toilets.
Other: Add ADA Unisex Restroom	\$10,000.00	each			1 Required		\$10,000.00	Add ADA compliant unisex toilet room.
Other: Provide ADA compliant handrails.	\$48.00	n.ft.			96 Required		\$4,608.00	Provide new hand rails at ADA ramp.
Sum:			\$102,080.80	\$468.60	\$80,543.40	\$21,068.80

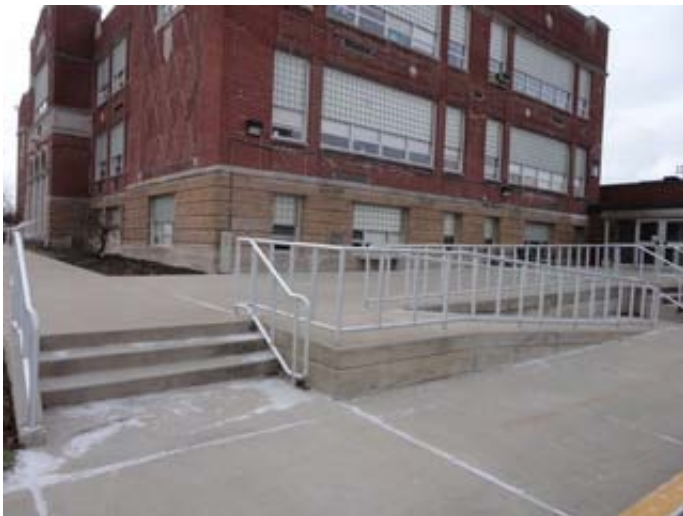
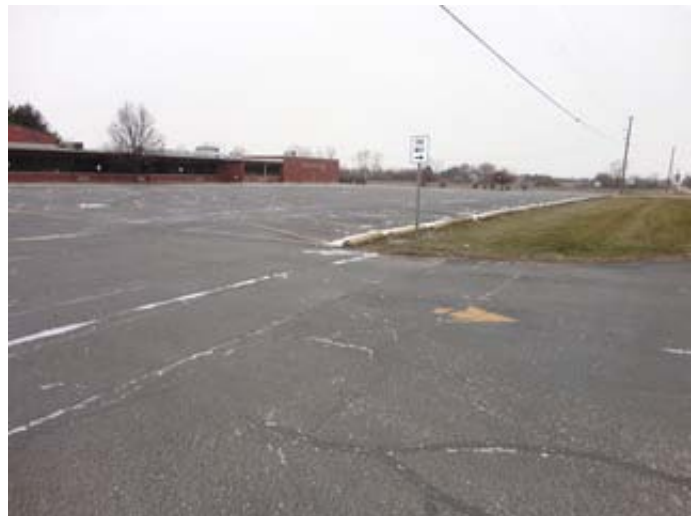
Ramp and Stairs at Entrance

Front Parking Lot

Item	Cost	Unit	Whole Building	Original Construction (1956) 2,343 ft ²	Classroom Addition (1959) 19,927 ft ²	Classroom Addition (1968) 7,369 ft ²	Sum	Comments
Replace Existing Asphalt Paving (heavy duty):	\$30.60	sq. yard		300 Required	1,800 Required	900 Required	\$91,800.00	(including drainage / tear out for heavy duty asphalt)
Asphalt Paving / New Wearing Course:	\$19.00	sq. yard		1,582 Required	10,443 Required	1,898 Required	\$264,537.00	(includes minor crack repair in less than 5% of paved area)
Bus Drop-Off for Middle	\$110.00	per student		16 Required	110 Required	38 Required	\$18,040.00	(Number of students should be rounded up to the nearest 100. \$5500 per bus; 40 students per bus; 80% of middle school students riding)
Concrete Curb:	\$18.00	ln.ft.		20 Required	120 Required	60 Required	\$3,600.00	(new)
Concrete Sidewalk:	\$4.69	sq.ft. (Qty)		12 Required	66 Required	40 Required	\$553.42	(5 inch exterior slab)

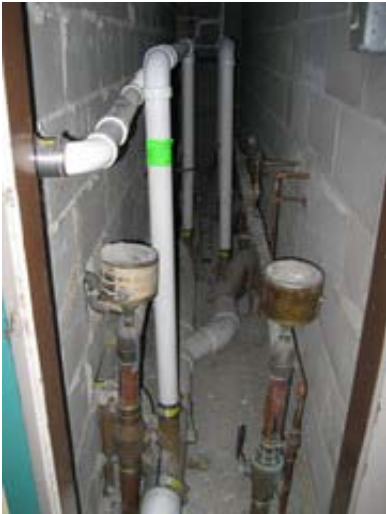
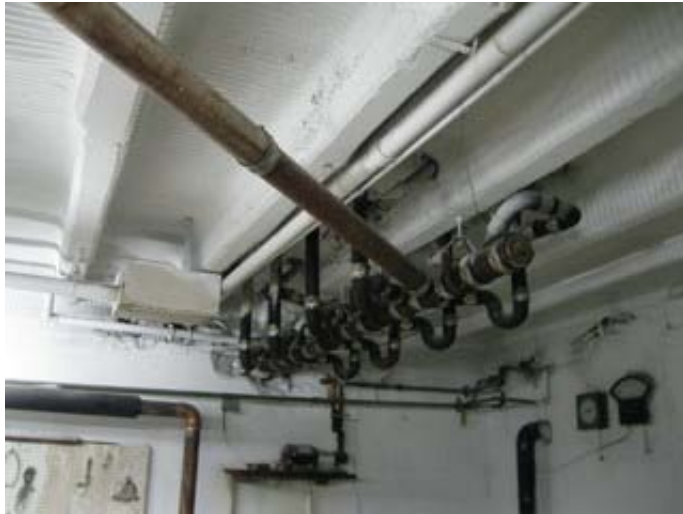
Sanitary Waste Lines

Recommendations: Existing conditions require no renovation or replacement at the present time.

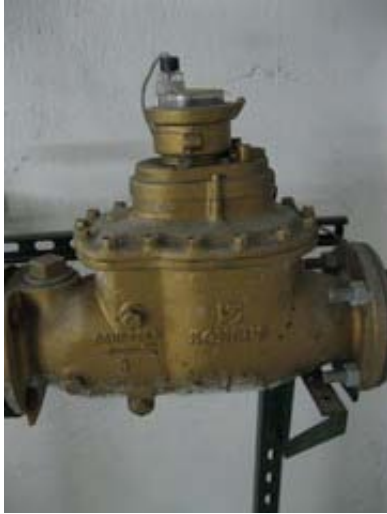
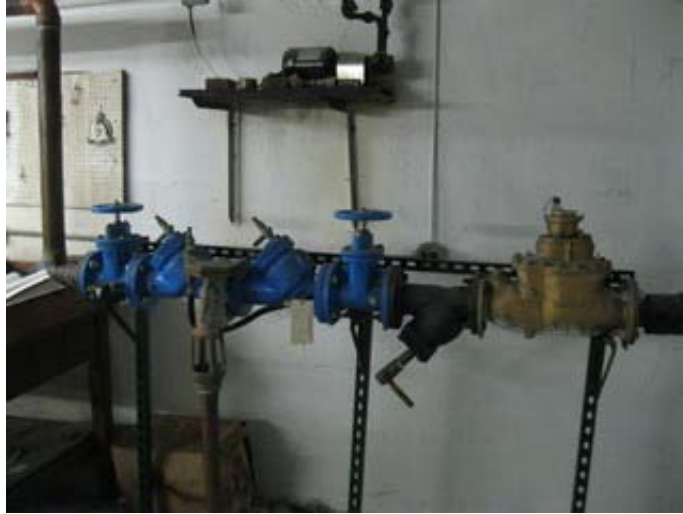
Incoming Domestic Water Service Meter

Incoming Domestic Water Service Line and Backflow Preventers

Recommendations: Provide a new city water supply line of adequate capacity to support the existing needs of the facility, as well as a future automated fire suppression system. Funding provided in Item U.

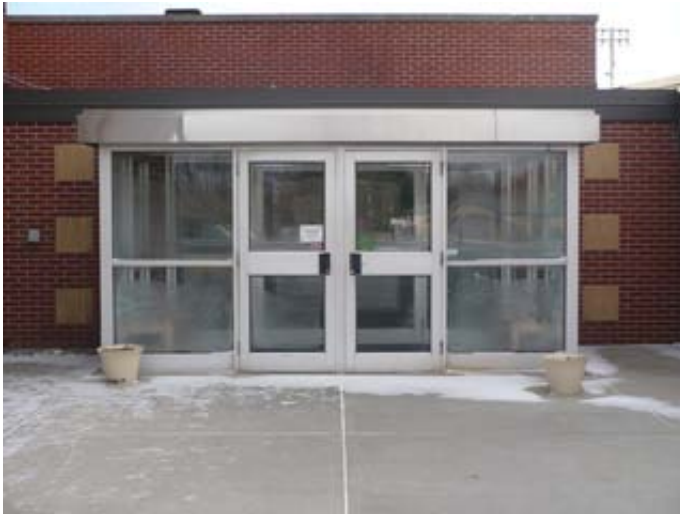
Entrance Vestibule of 1959 Addition

Recommendations: Replace all exterior doors, with the exception of the 1968 Addition FRP entrance doors to comply with Ohio Building Code, ADA, and Ohio School Design Manual guidelines, and due to condition. Replace overhead door due to condition.

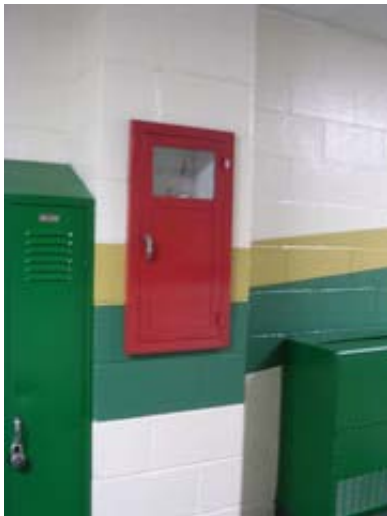
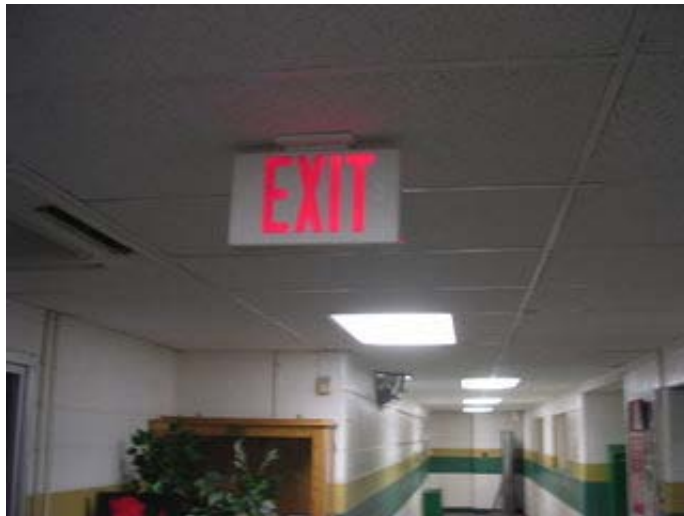
Typical Fire Extinguisher Cabinets

Typical Exit Lighting Signage

Recommendations: Provide new automated fire suppression system to meet Ohio School Design Manual guidelines. Provide increased water service of a capacity sufficient to support the fire suppression system, funding included in fire suppression funding. Provide new emergency generator, with funding provided via complete replacement of electrical system in Item D.

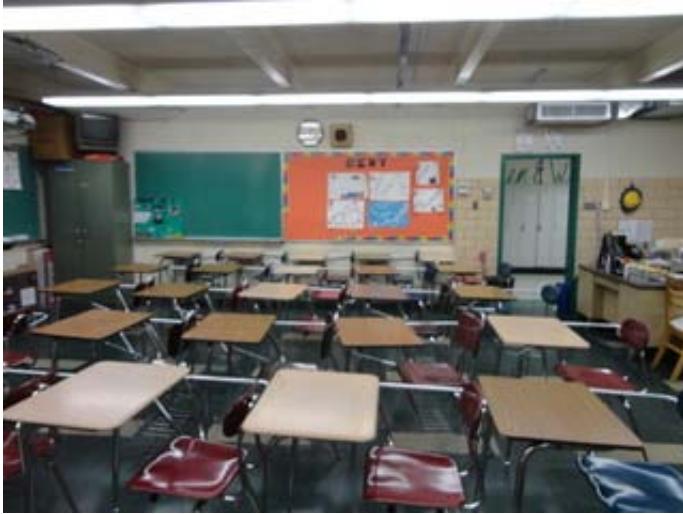
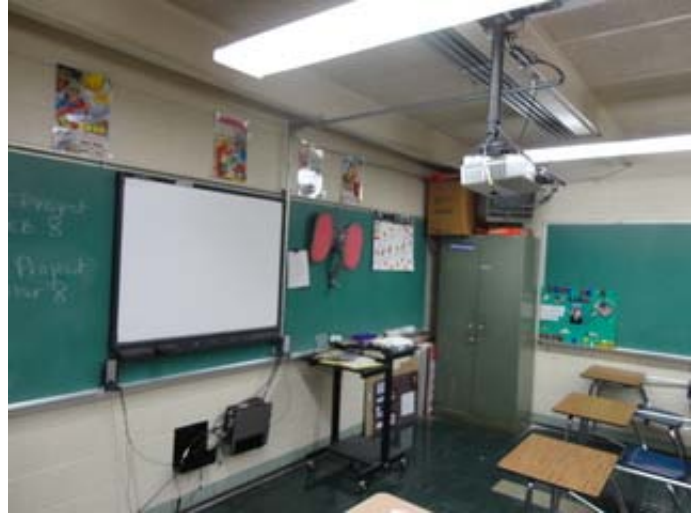
Classroom Desks

Classroom Wardrobe Storage

Recommendations: Provide for replacement of outdated or inadequate furnishings.

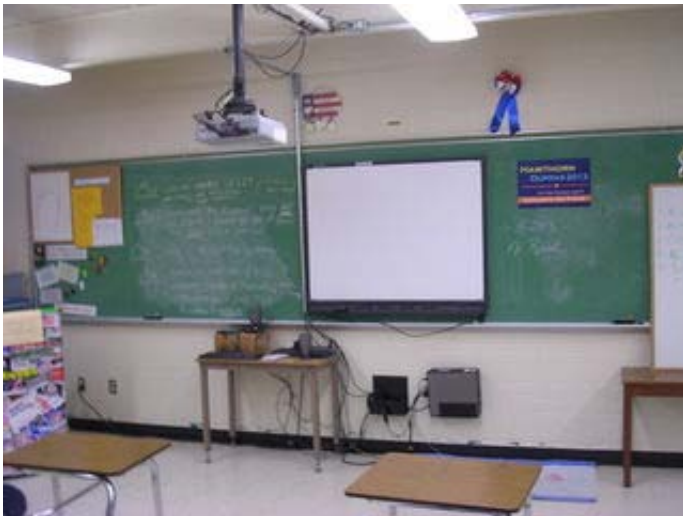
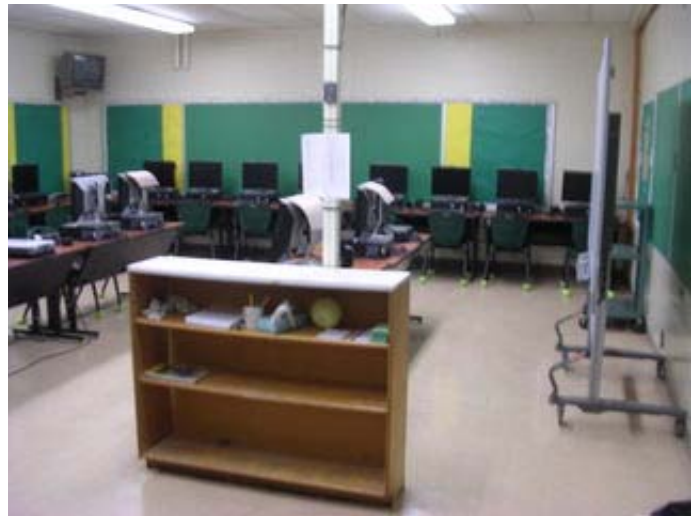
Typical Classroom Smart Board System

Student Computer Lab

Recommendations: Provide complete replacement of technology systems to meet Ohio School Design Manual requirements, and to sustain the capacity to keep pace with technological development. Provide a compliant centralized clock system, included in replacement cost.
